Outfall 33 Rehabilitation

Urgent Sewer Repair using Pilot Tube Construction Method

Ruben Gonzalez, M.Sc., P.E.
Bureau of Environmental Services
City of Portland, OR

January 12th, 2017

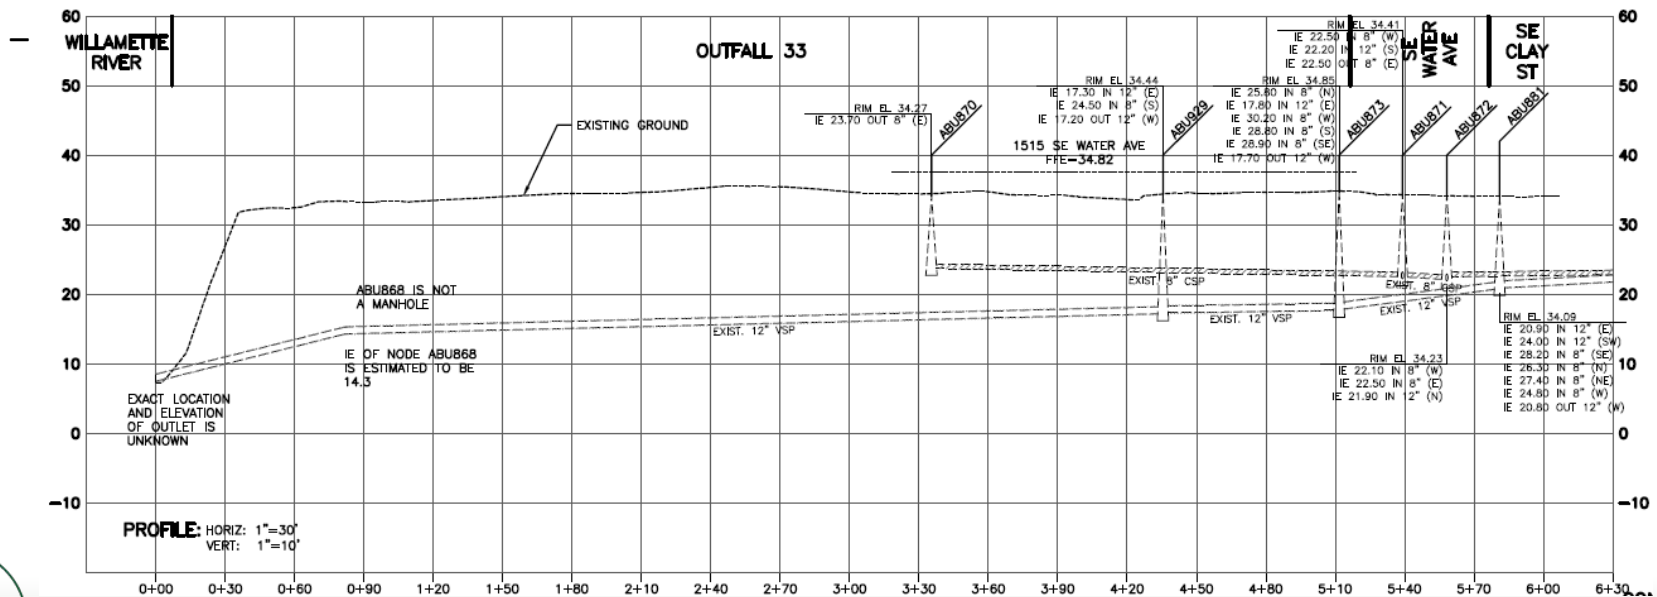
- Recent inspection dates: August, 2015; April, 2014.
 - Pipe segment ABU929-ABU868 has a grade 5 structural score.
 - Pipe segment ABU873-ABU929 has is a grade 3.
- OF33 is buried by undocumented fill.

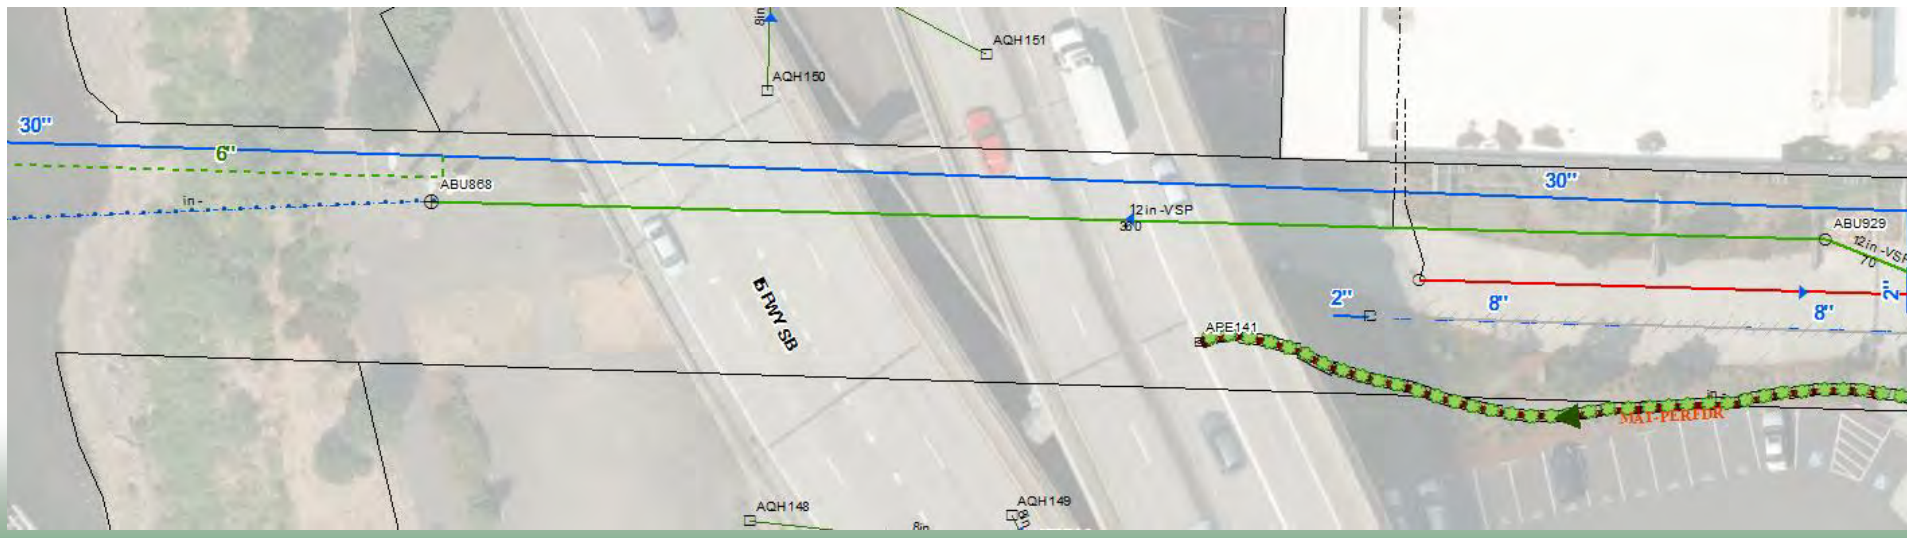
- **30" water transmission line**
 - Installed 1910.
 - Major transmission conduit serving Downtown PDX.
 - Recent repair conducted beneath Willamette River (2015).
 - Based on recent survey, approximate horizontal separation varies from approximately 5-12' center-to-center (3.25-10.25' skin-to-skin).
 - Approx. IE = 11.25' (approx. IE of existing storm main @ ABU868 = 14.3').
 - 6" blow-off line runs approx. 6' south of transmission conduit.

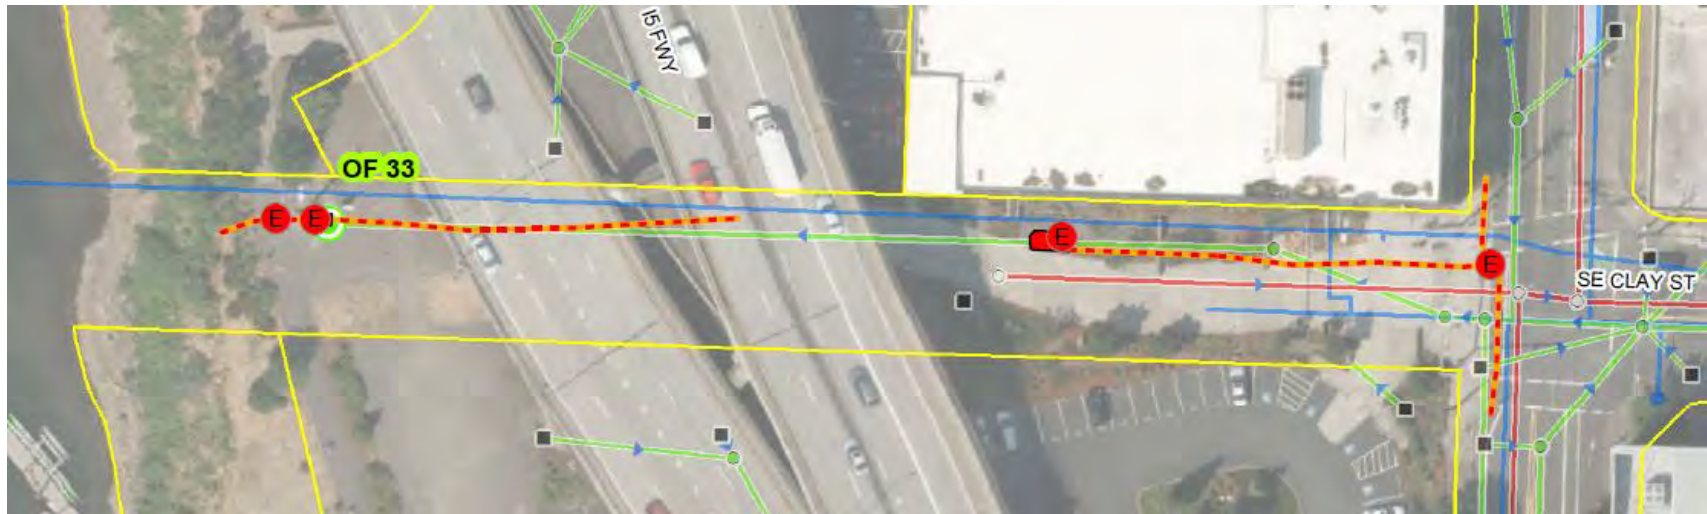
- **PGE Vaults & Conduit**
 - Two major vaults along existing storm main alignment
 - High voltage conduit is above significant portions of storm main
 - Possible PGE abandonment - ~2yrs

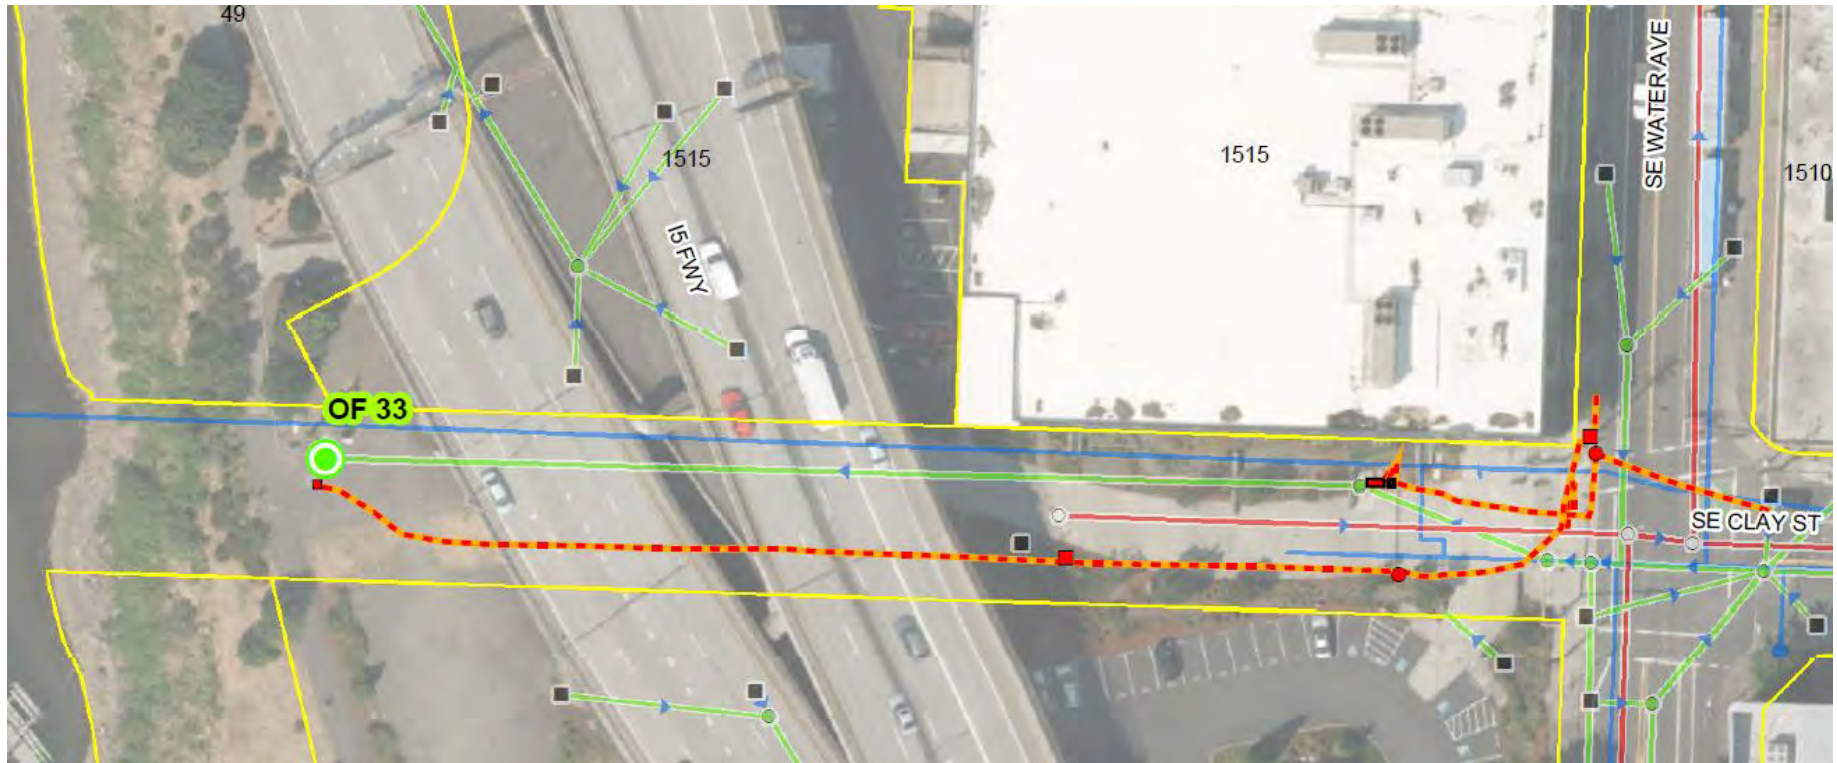
- CenturyLink / Time Warner
 - Vault & telecom conduit above storm main and near ABU929

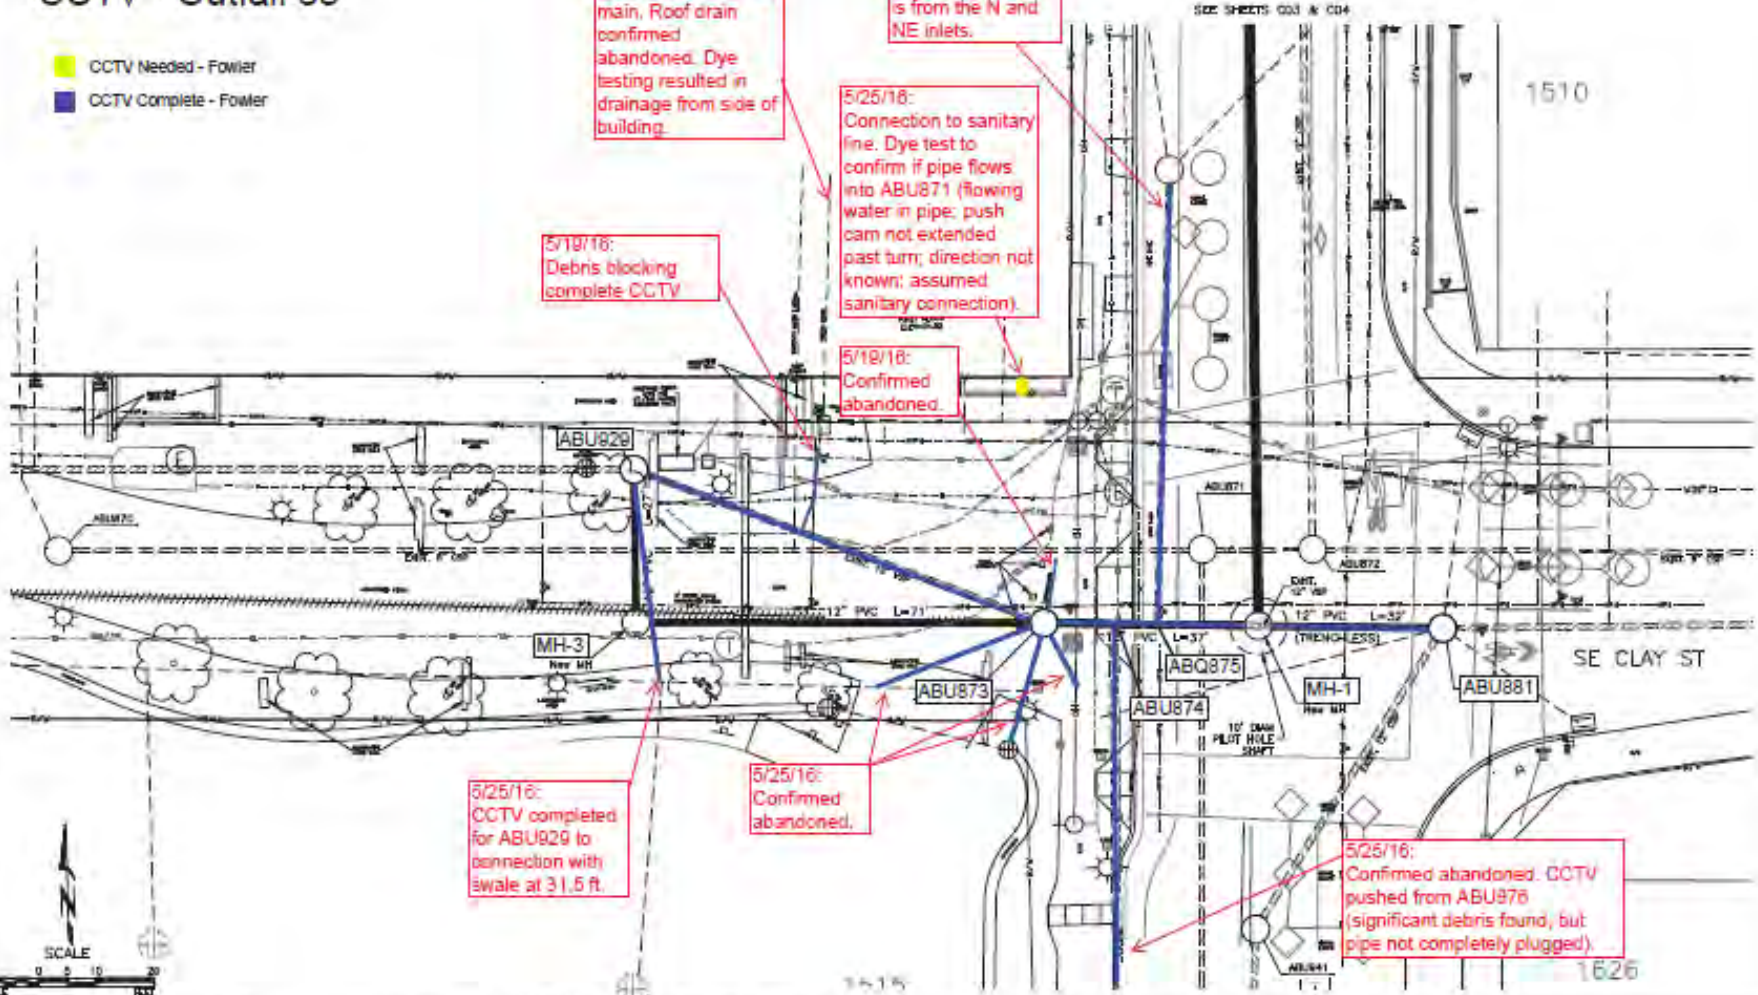
**OUTFALL 33
REHABILITATION**
SE CLAY ST
PLAN

5/26/16:
Connections to storm main, Roof drain confirmed abandoned. Dye testing resulted in drainage from side of building.

5/19/16:
Only incoming flow is from the N and NE inlets.

5/25/16:
Connection to sanitary line. Dye test to confirm if pipe flows into ABU871 (flowing water in pipe; push cam not extended past turn; direction not known; assumed sanitary connection).

5/19/16:
Debris blocking complete CCTV

5/19/16:
Confirmed abandoned.

5/25/16:
CCTV completed for ABU929 to connection with swale at 31.5 ft.

5/25/16:
Confirmed abandoned.

5/25/16:
Confirmed abandoned. CCTV pushed from ABU976 (significant debris found, but pipe not completely plugged).
