Washington, D.C.
March 27-31, 2011

Paper D-5-01

REDUCING PROJECT UNCERTAINTY FOR RESIDENTIAL SEWER CURED-IN-PLACE-PIPE (CIPP) PROJECTS

Erik Waligorski, PE¹, and Ron Hall²

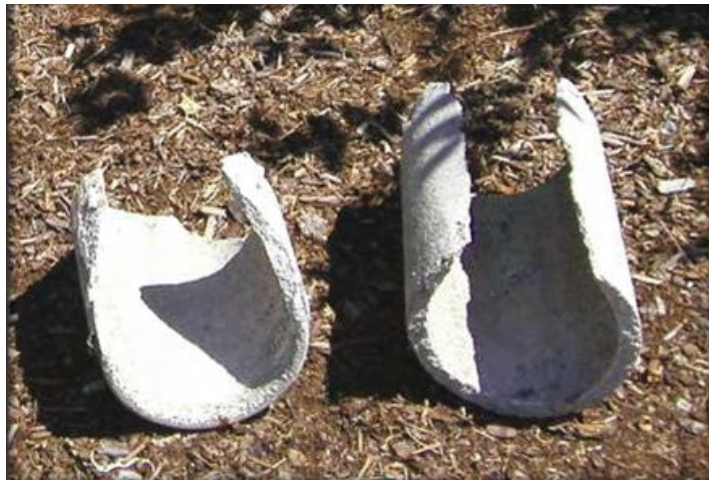
Figure 1. Existing sewer pipe from Chelsea Park Sewer Rehabilitation Project.

Figure 1 shows two sections of existing pipe that were discovered during the CCTV inspection of the sewer lines in the Chelsea Park neighborhood. The bottom section of these pipes had completely eroded away. These sections of pipe were only discovered because the CCTV camera disappeared during the inspection. These sections could not be lined using CIPP technology and were dug up and repaired using conventional open-trench construction.

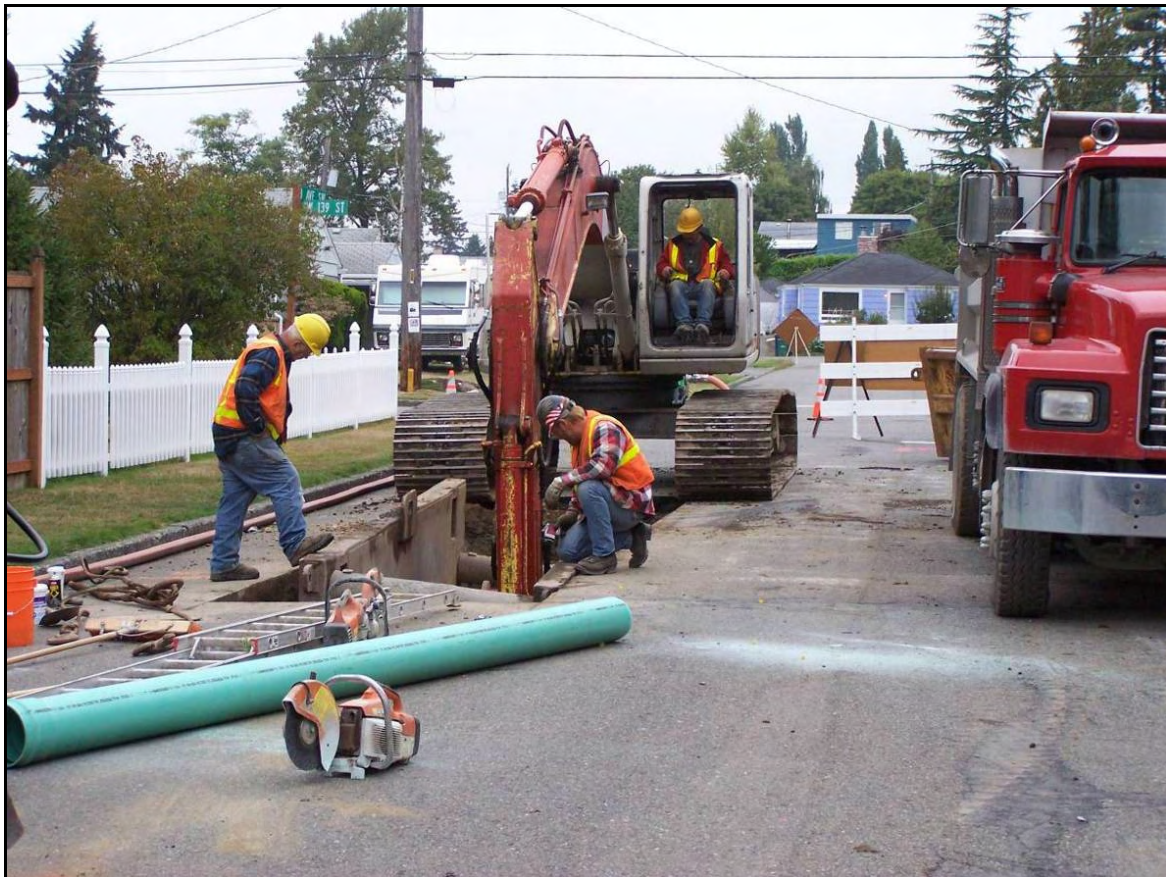
The repair/replacement contract consisted of all the open-trench excavations that were required based on the CCTV review. These open-trench repairs replaced severely sagged pipe, removed pipe that had collapsed and replaced pipe that was undersized. Generally, the contractors bidding the repair/replacement project were local contractors familiar with SWSSD and the local road and land use agency requirements. This meant that these contractors understood the risks and requirements for constructing the project in the area and did not need to inflate their bids to cover those factors.

Figure 3. Spot Repair/Pipe Replacement Construction

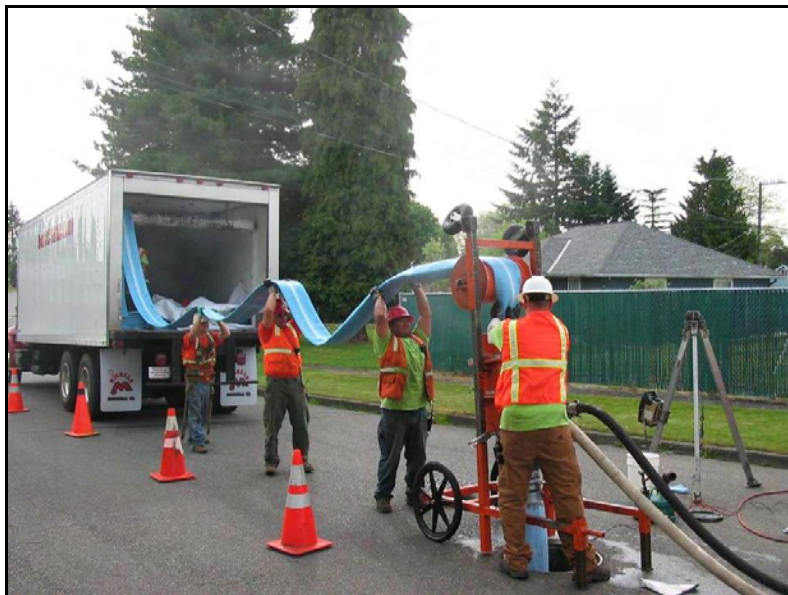
Figure 5. CIPP Rehabilitation
