# Pacific Northwest Trenchless Review

2016

## Remote- Controlled Boring in Bend, Oregon

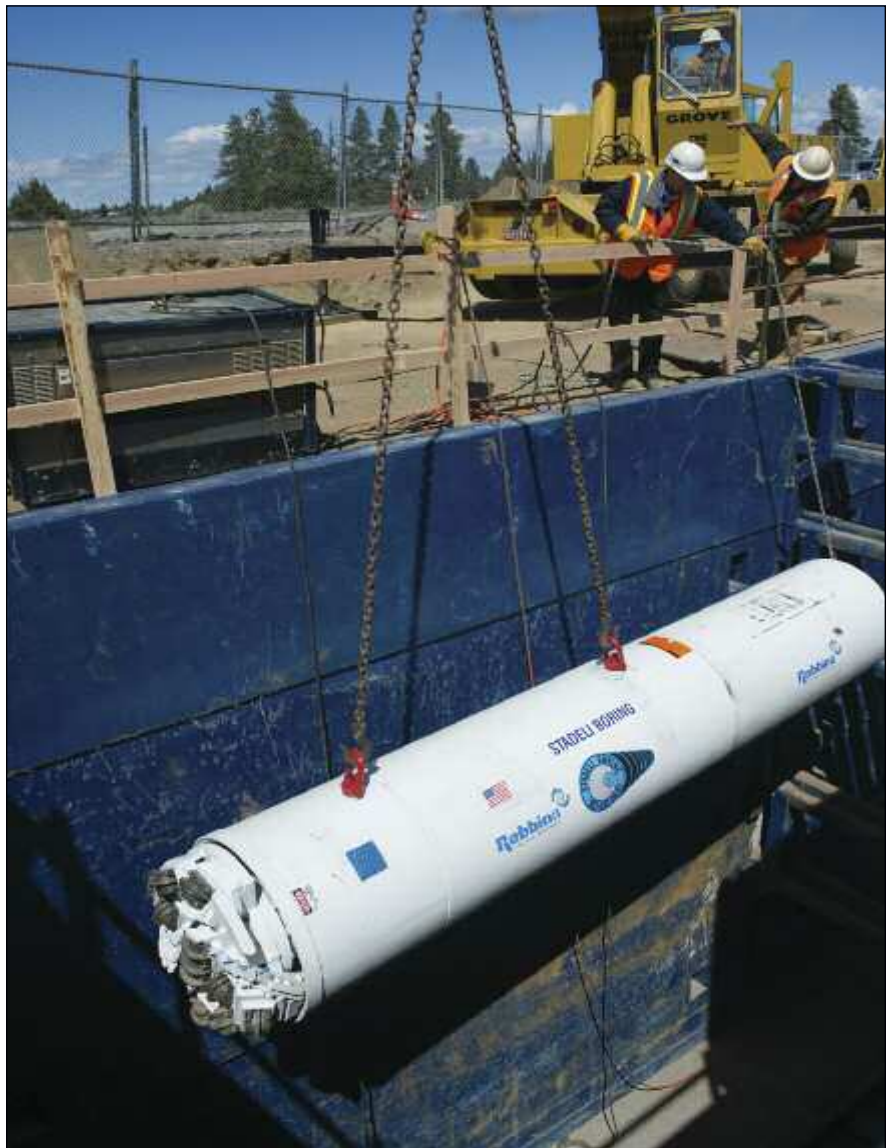
*The Robbins 36-inch-diameter SBU-RC was launched at a jobsite in Bend, Oregon, for contractor Stadel Boring & Tunneling in April 2015.*

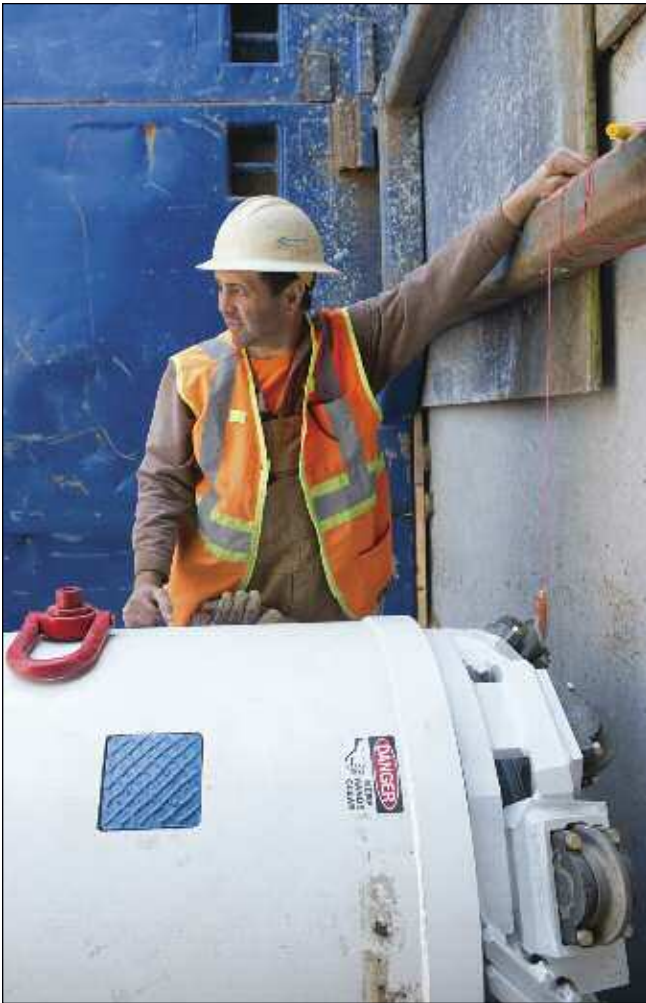
*The Stadeli crew lines up the SBU-RC in the launch pit to bore a 323-foot-long crossing for a new gravity sewer interceptor.*

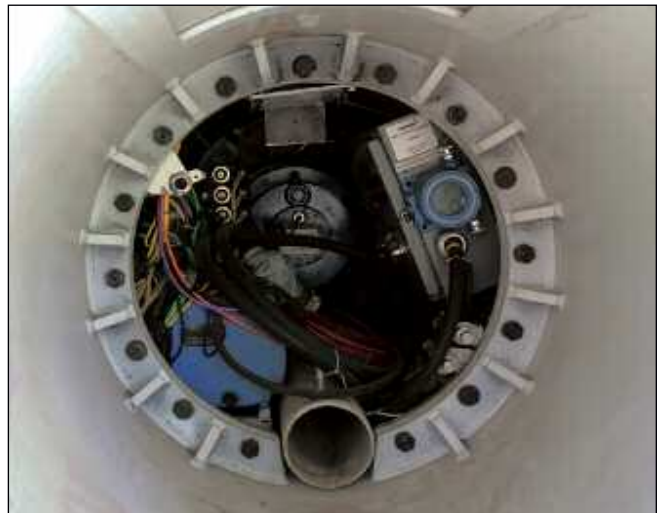
*The compact SBU-RC operates using an in-shield drive motor for torque. View shows the inside of the SBU-RC with drive motor.*

Much like other small boring units, the new machine uses a mixed ground cutterhead fitted with 6.5-inch disc cutters to efficiently chip rock from the excavation face in the same mechanism used by larger TBMs. And while the SBURC method is

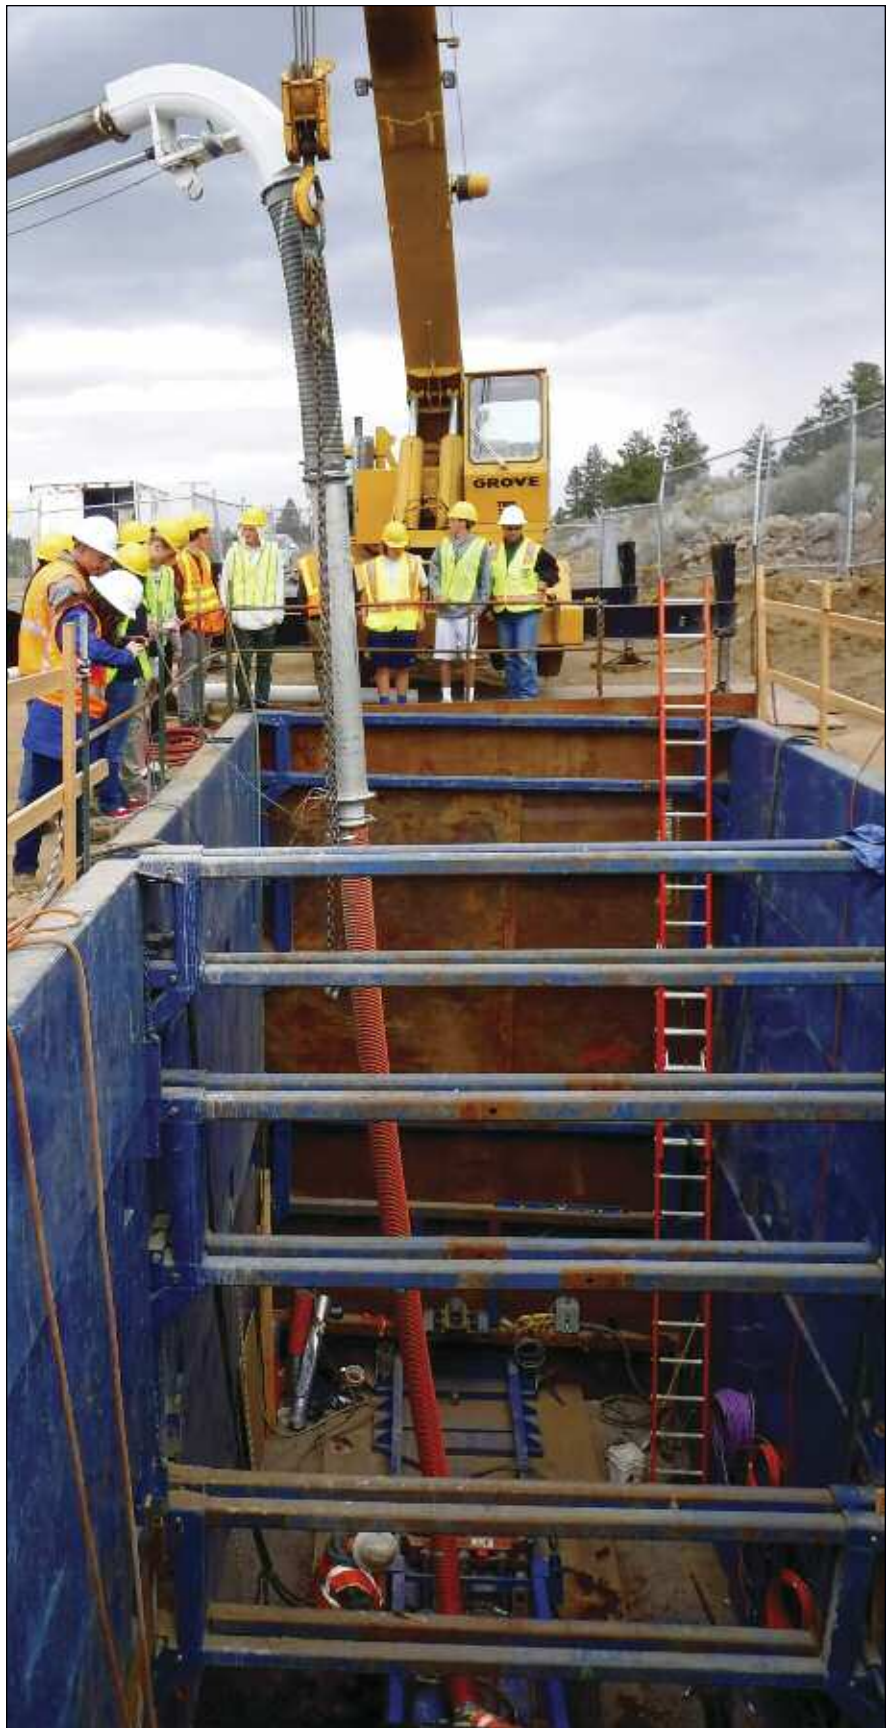
*Spoils are removed from behind the SBU-RC cutterhead directly to the surface using a vacuum truck.*

similar to microtunnel boring machines (MTBM) in many ways, it differs significantly in its spoil removal system. MTBMs require a slurry to pump the spoils back to the surface, and the slurry must be cleaned and treated at a spoils plant, which can be time-consuming, messy, and expensive. In this case, the significant void space and fractures in the rock would have made it difficult to maintain slurry circulation with an MTBM. The SBURC used a vacuum system for muck removal, connecting a vacuum truck to a six-inch suction line, which pulled material to the surface from behind the cutterhead. The launch pit remains clean and dry as the spoils are contained in the vacuum truck.

As tunneling progressed, the capability of the 4,000-cfm vacuum truck to clear spoils from the line slowly dwindled, until finally at about 100 feet of advancement it was no longer effective and the rock spoils clogged the vacuum line. This truck was replaced with a 6,000-cfm vacuum truck, increasing the suction by 50 percent. After crews replaced the clogged lines, this truck was suitable for the remainder of the 323foot tunnel. Additionally, the new truck had a larger tank capacity, allowing the installation of

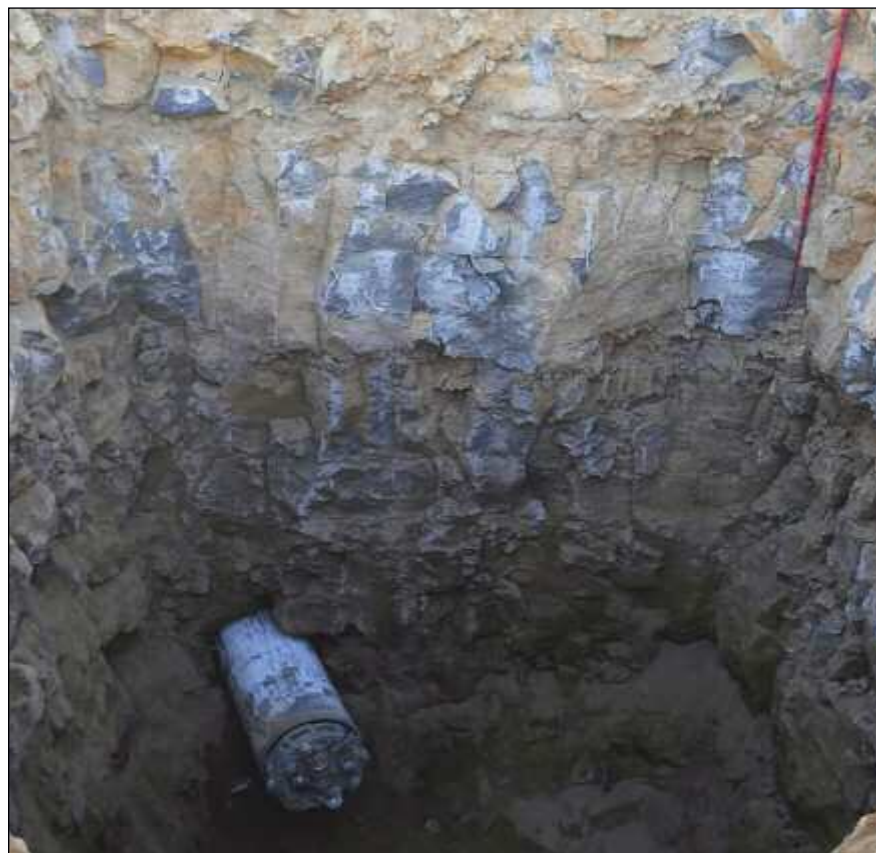
*The Robbins SBU-RC broke through two weeks ahead of schedule on May 5, 2015. The blocky basalt subsurface conditions are seen here at the exit pit.*

The machine bored through basalt rock full of fissures, fractures, and rubble pockets between 5,000 and 7,000 psi UCS. While the start-up presented challenges, crews soon achieved rates of 20 feet per day after the modifications to the cutterhead and vacuum system. As the crew became accustomed to the machine, advance rates increased to 40 feet per

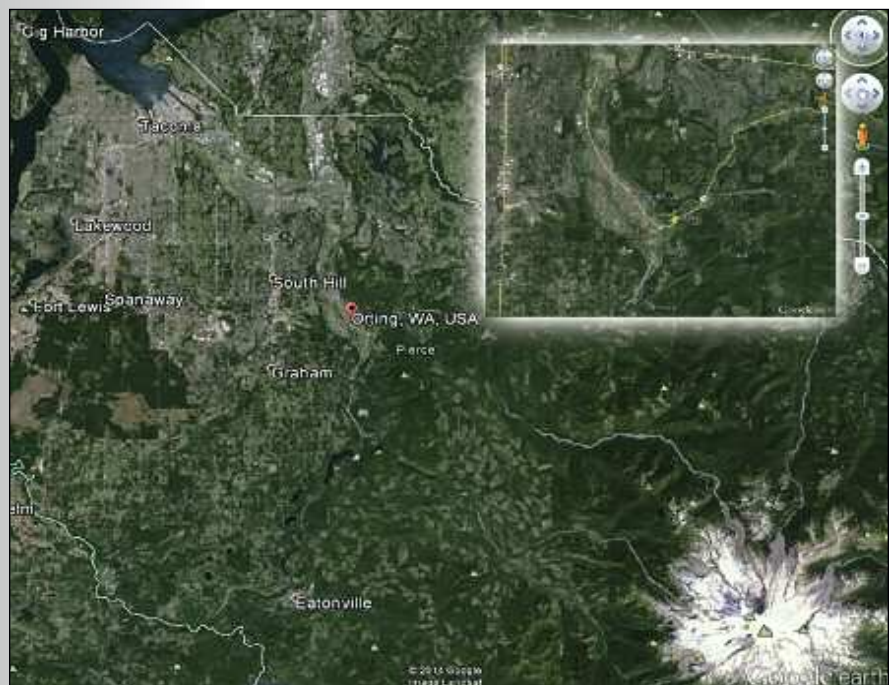
Figure 1. Vicinity Map of Orting, Washington

The project is located southeast of Orting. Figure 1 shows the project area relative to nearby cities and relative to Mount Rainier (bottom right of the primary image).

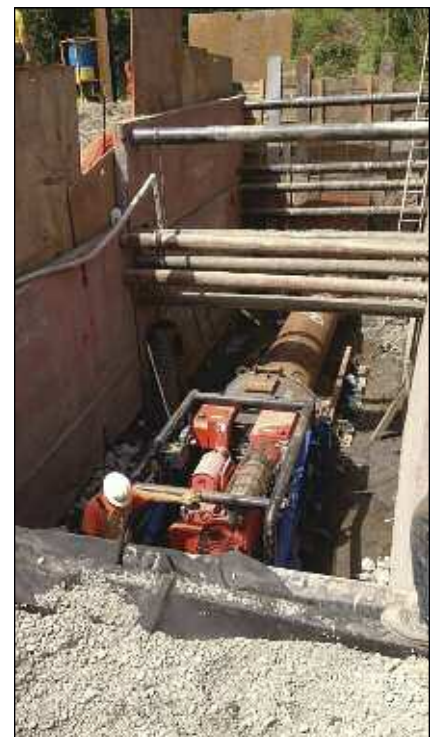
Figure 3. Auger Bore Jacking Frame Set-up

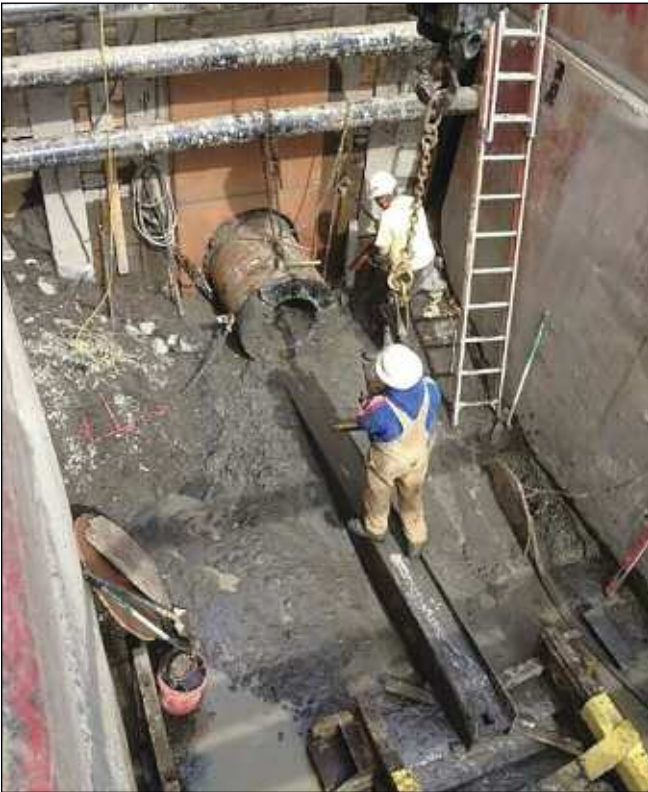
*Figure 4. Wet soil is on the floor of the launch pit.*

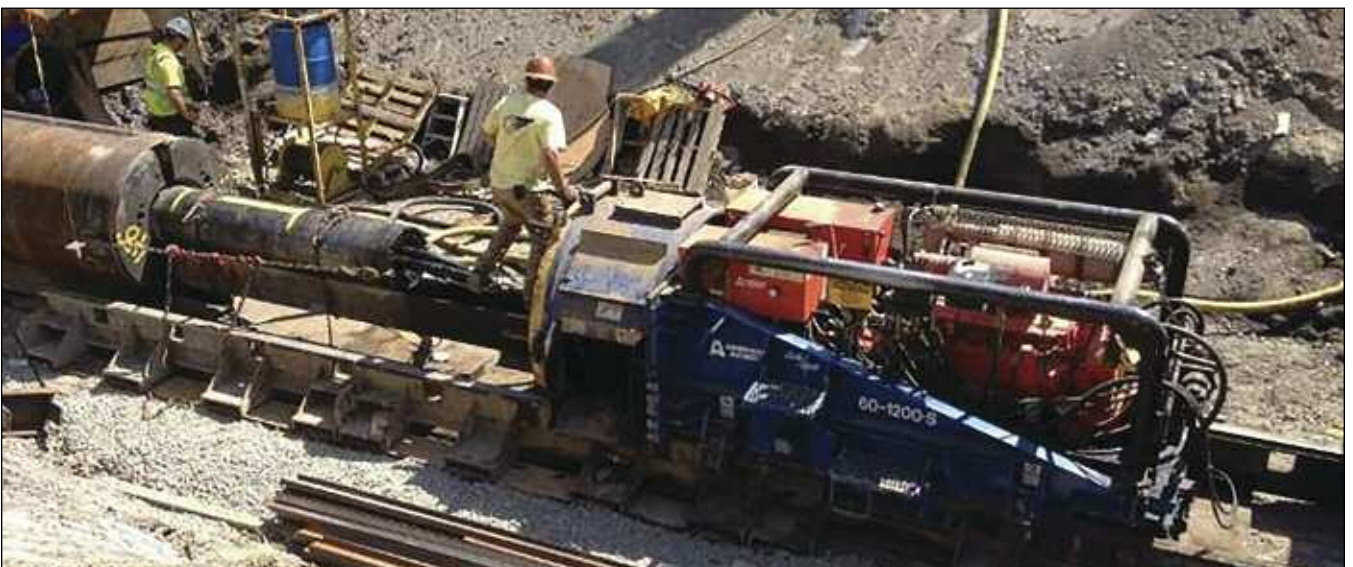
*Figure 5. Pipe Ram/Jacking Frame Combination*

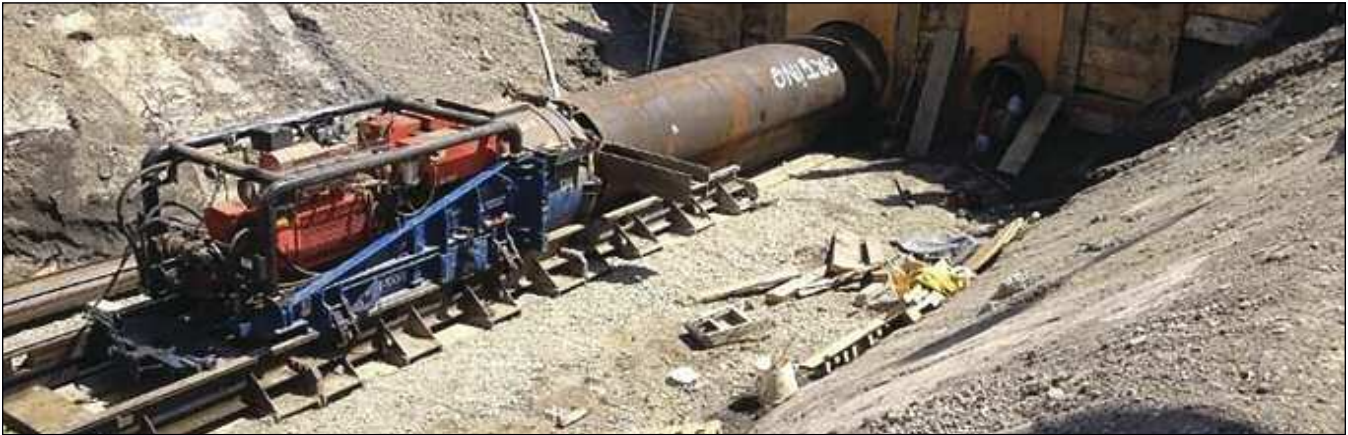
Figure 6. Auger Bore Set-up

The contractor proposed switching to auger boring. He believed that the vibrations would go away, the weight of the soil in the pipe would be reduced and the soil would not liquefy. The design team was concerned that if auger boring were used there could be over-excavation at the face of the casing and may cause excessive settlement or sinkholes at the overlying roadway surface. After discussions with the contractor and WSDOT, the contractor was allowed to change methods, provided he held to the grade and settlement requirements in the specifications and he maintained the cutting head of the augers at least three feet inside the lead casing.

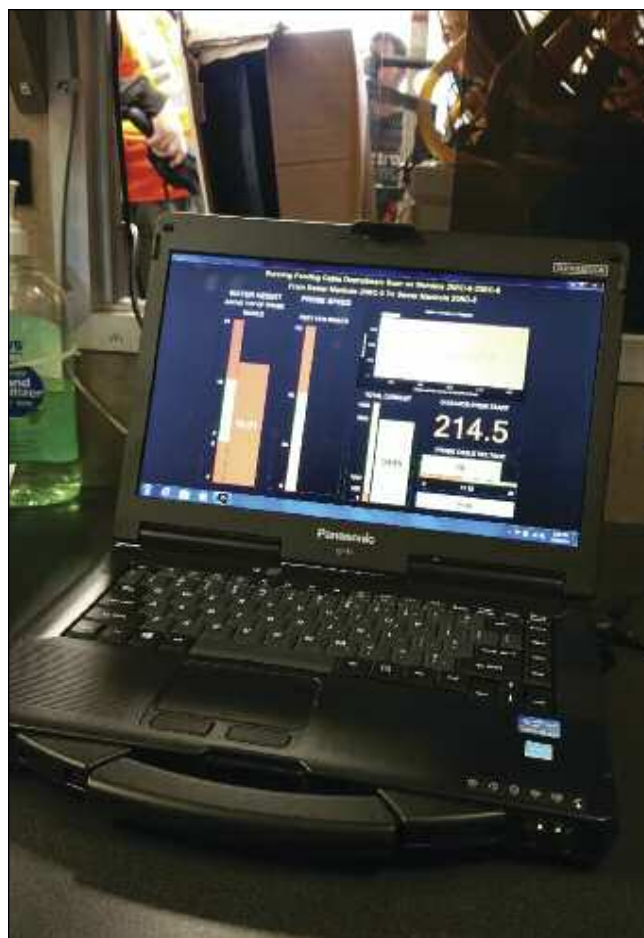
As the Electro Scan electrode, called a probe, passes through the pipe, it measures the variation of electric current flow through the wall of the pipe, then through the ground to an electrode on the surface – a metal stake driven into the ground.

Taking an electrical measurement every 14 milliseconds, the data is transmitted back up the CCTV truck’s cable and reel, and

then to the Electro Scan controller. There, the data is synched and delivered to the truck’s on-board PC which records all the data and operates the system via Electro Scan’s desktop application software.

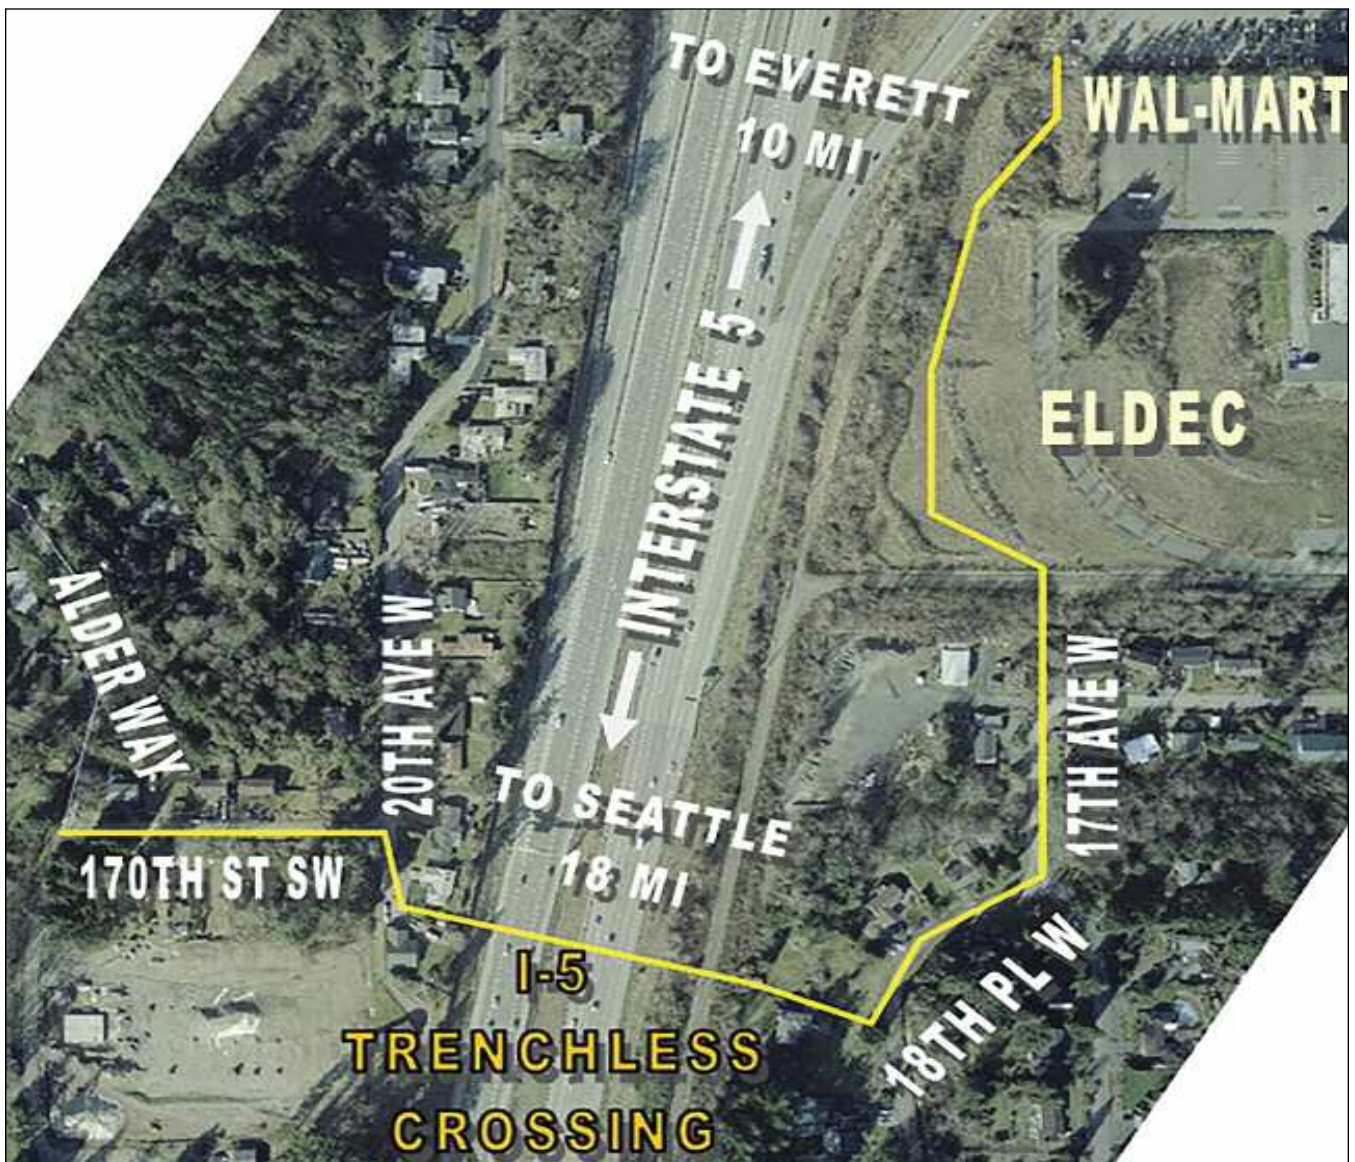
Figure 1: I-5 Trenchless Crossing for Martha Lake Project

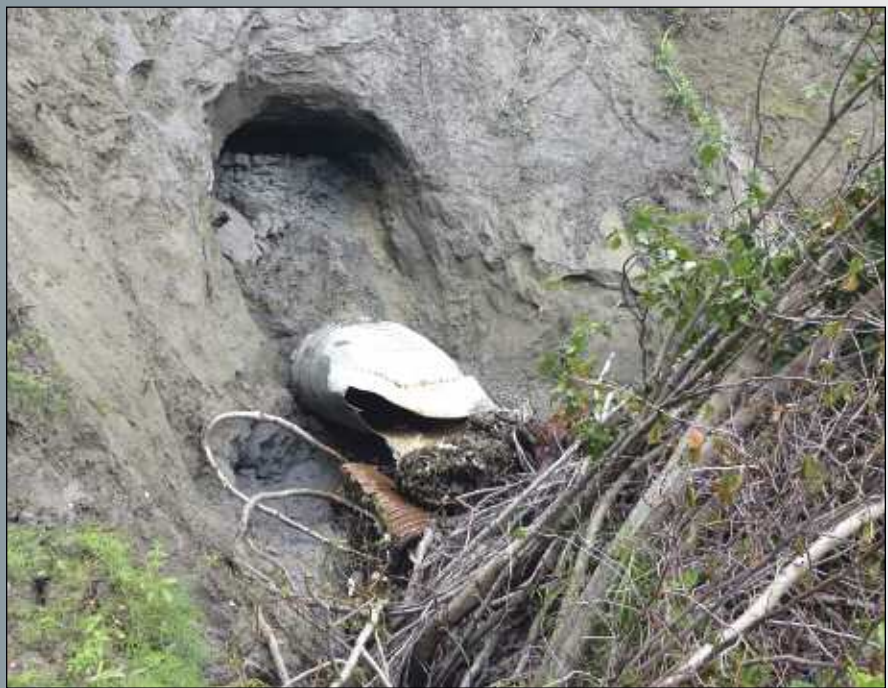
*Collapsed outfall pipe and slope failure*

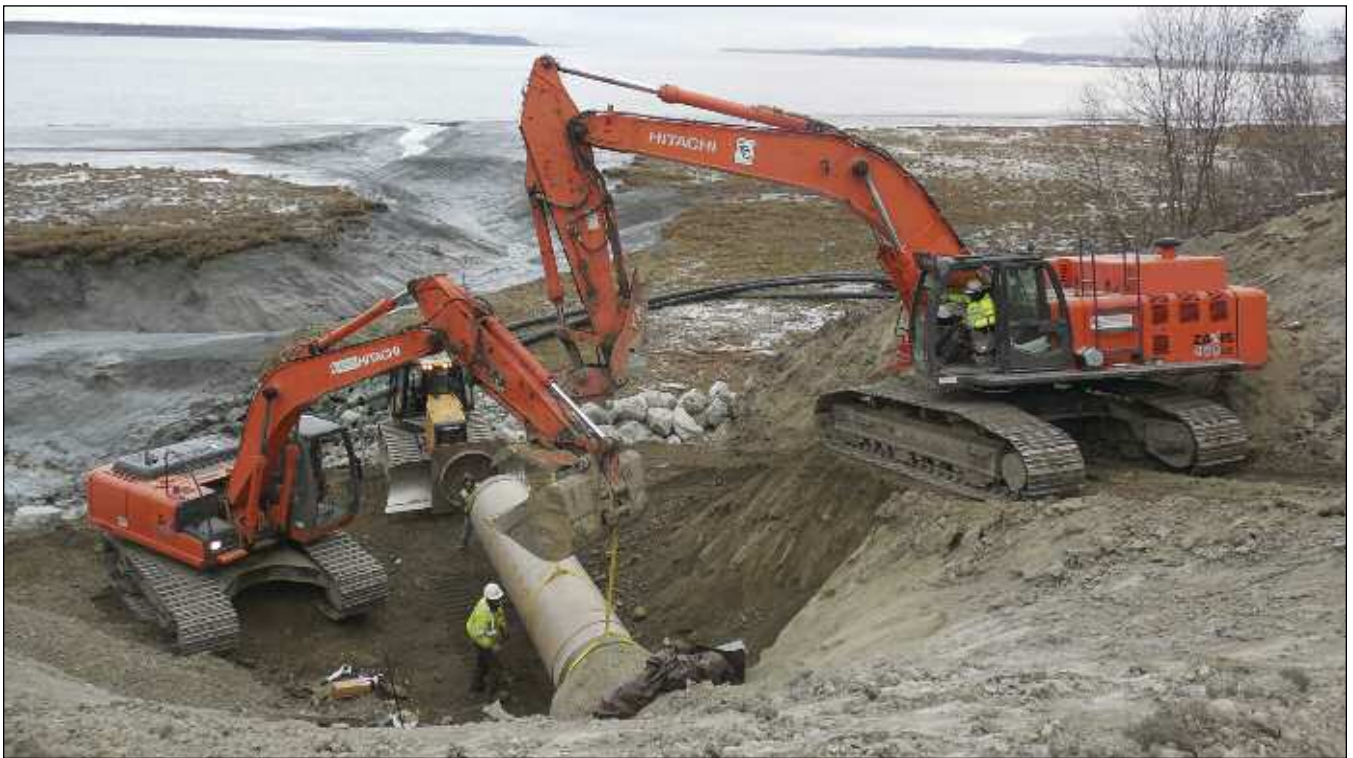
*Insertion of liner into host pipe*

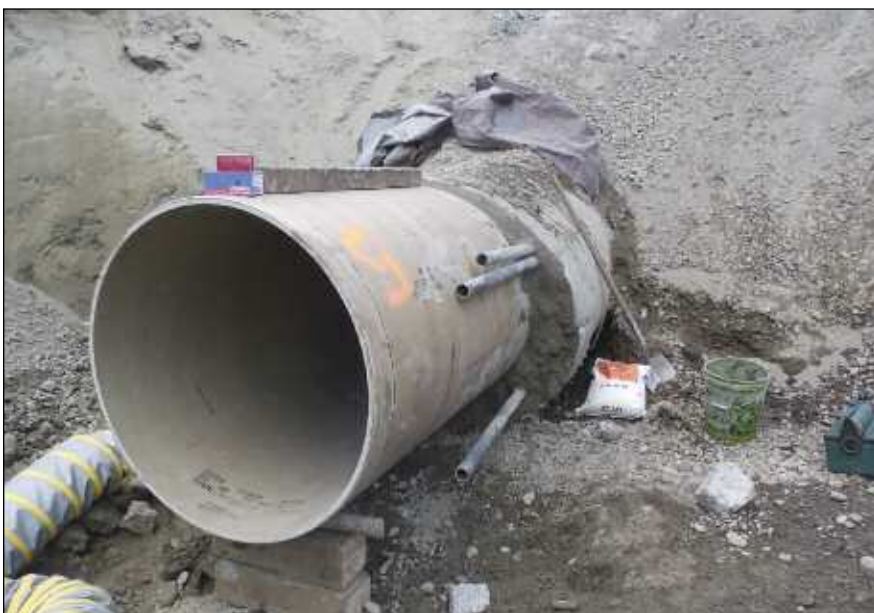
*Annular space grout strengthened the system and filled voids in the host pipe.*

After the FRP was installed in each segment, the annular space was grouted with a low-density cellular concrete (less than 60 pcf). The lift station operations were changed in order to surcharge the liner, keeping it full of water while the annular

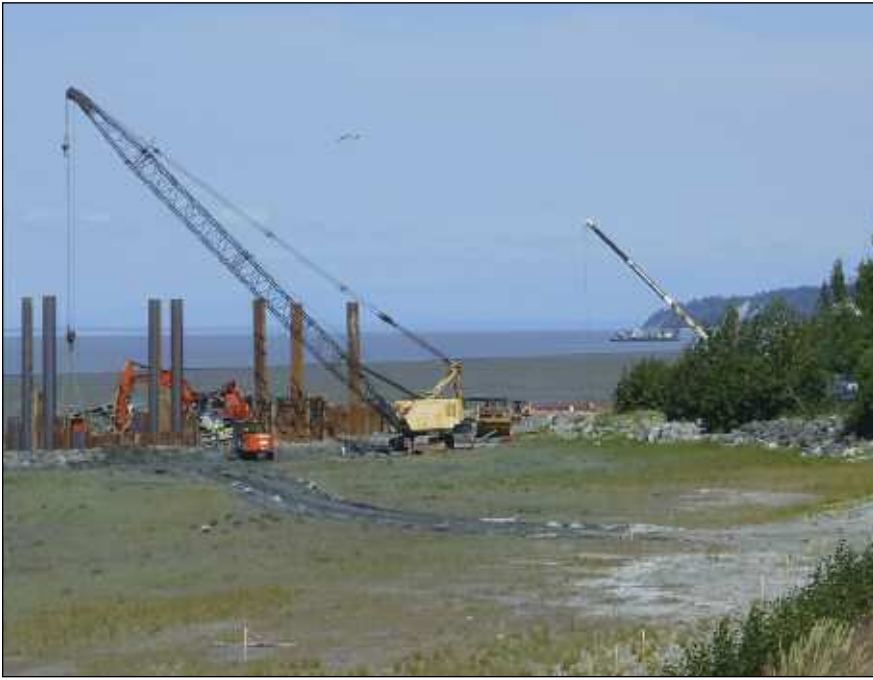
*Tidal zone work area during low tide*

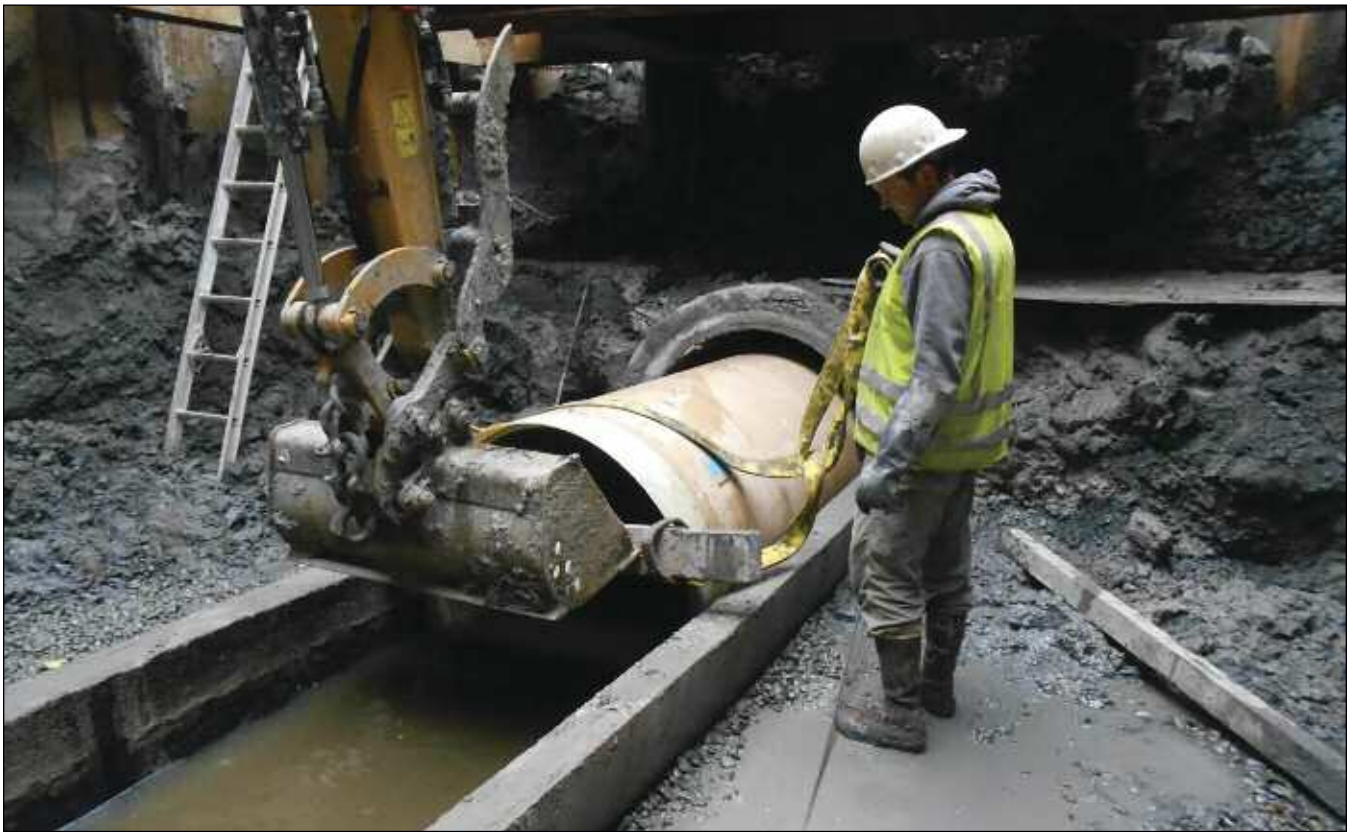
*Sliplining in live sanitary sewer flow*

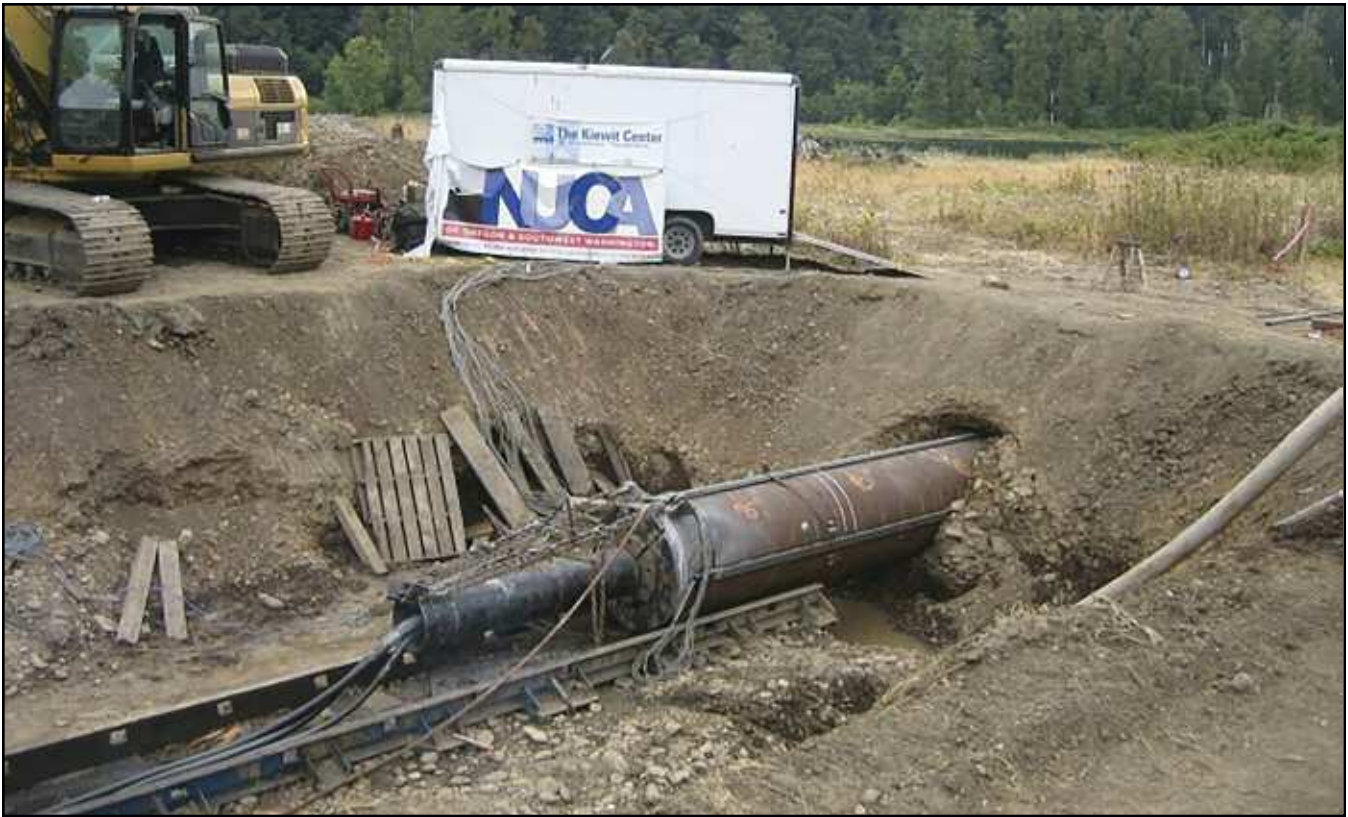
Figure 1. 400 mm HammerHead used during measurement of ground vibrations

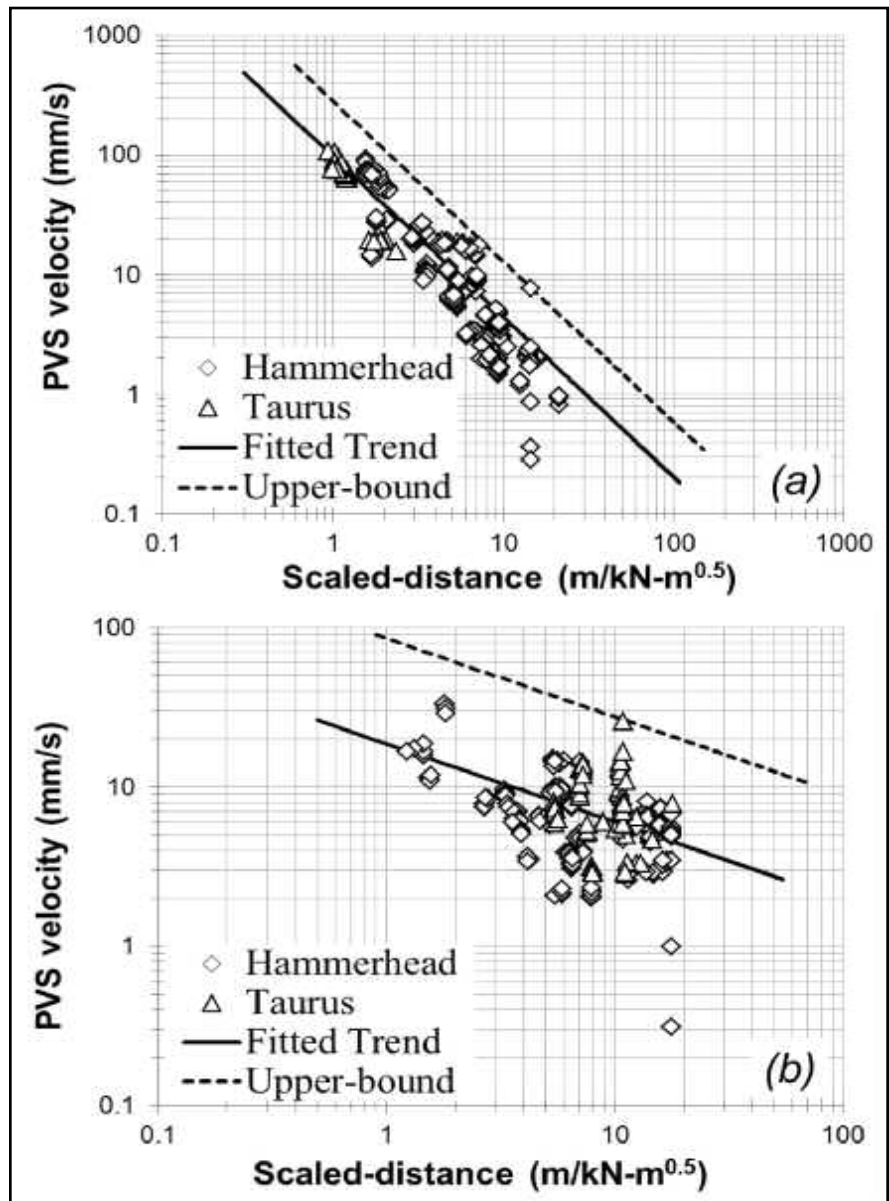
Figure 2. Ground vibration measurements and calibrated attenuation models for (a) forward propagation and source of energy at the rear end the pipe and (b) lateral propagation and source of energy at the rear end the pipe (modified from Meskele and Stuedlein 2015c)

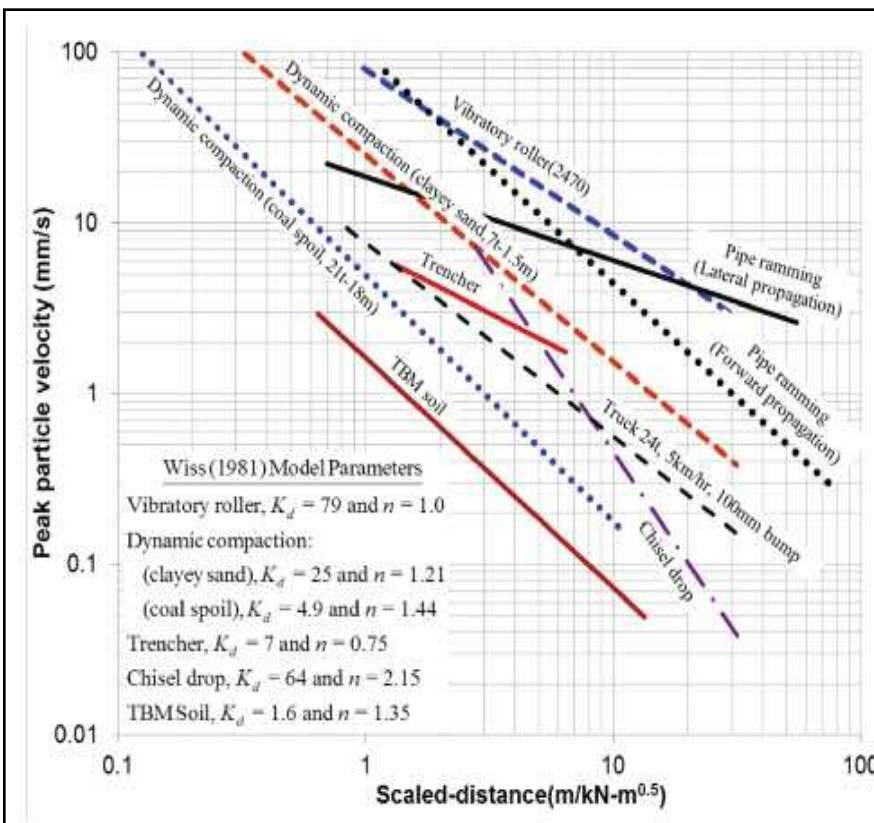
Figure 3. Variation of peak particle velocity with scaled-distance for various types of construction equipment (modified from Dowding 2000 and Meskele and Stuedlein 2015c)

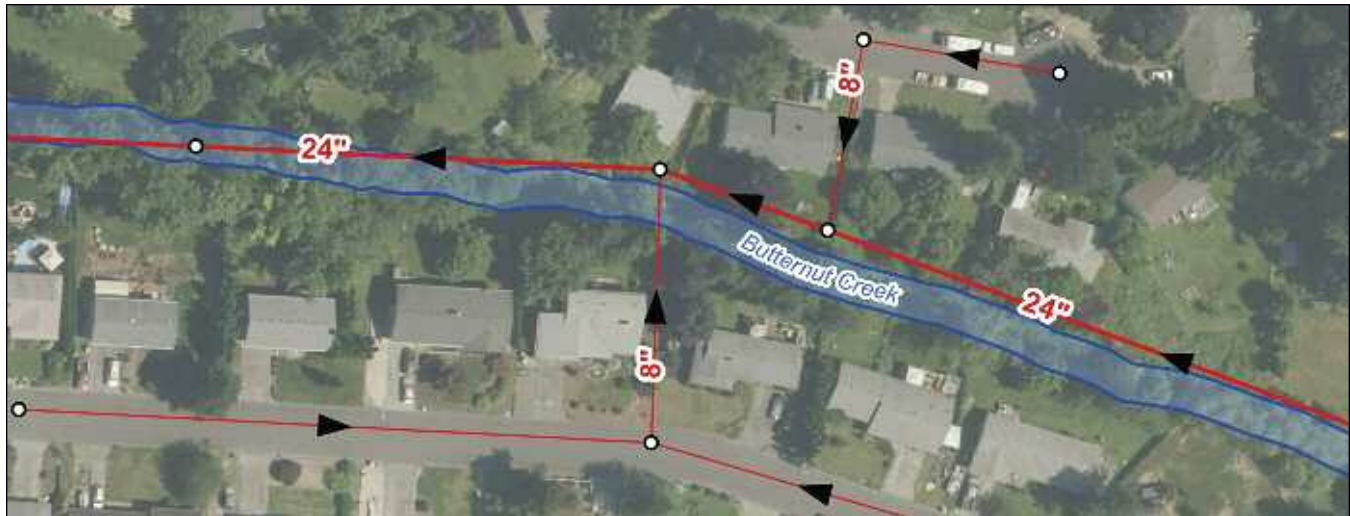
*Figure A: Interceptor in relationship to creek*

The full length of this interceptor is located within the Butternut Creek corridor. Figure A illustrates the location of the interceptor within the creek corridor. To further complicate access issues, the surrounding neighborhood development had limited the access. This particular

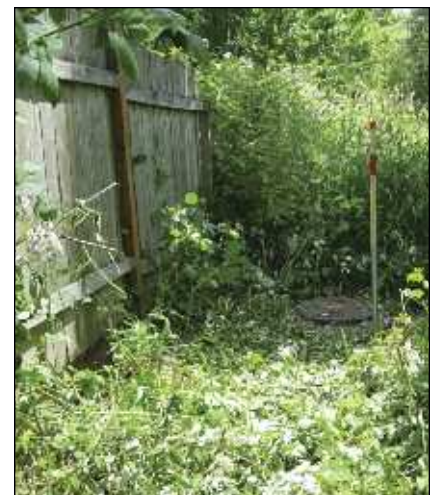
*Figure B: Factors limiting access to interceptor*

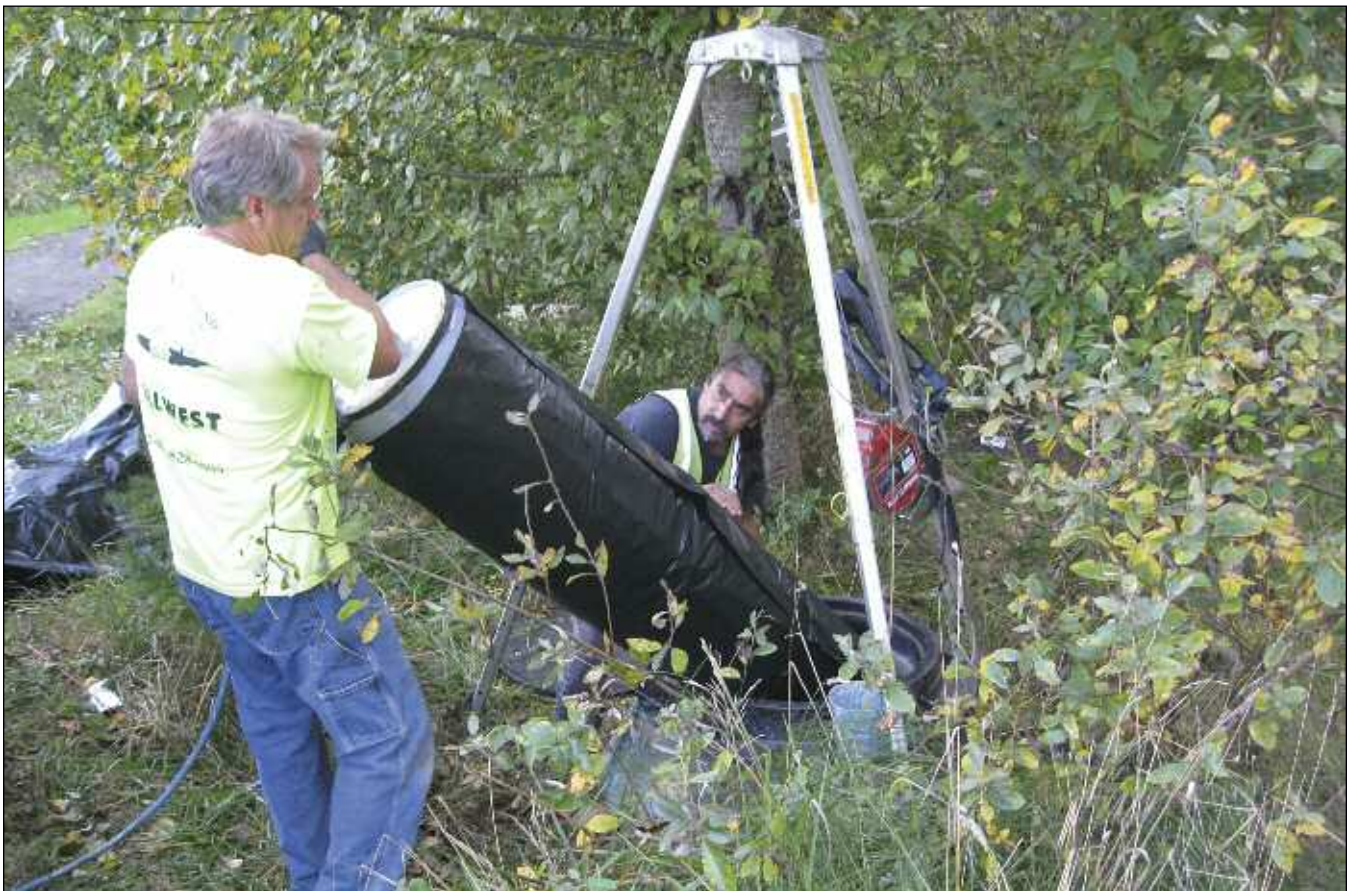
*Figure C: UV-curing point repair insertion*

The UV-cured short liners are installed like other lining sys-

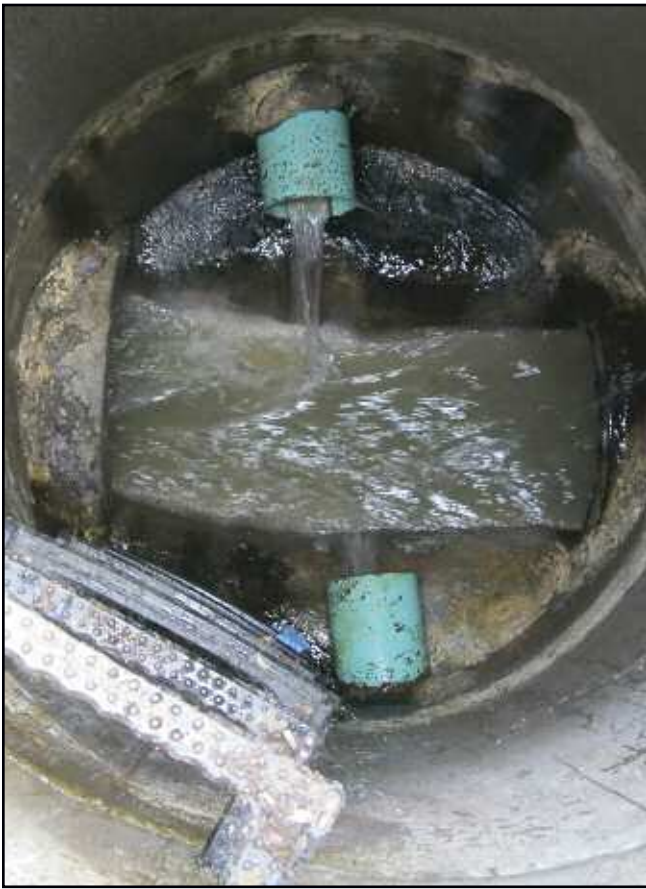
*Figure D: Manhole condition prior to rehab*

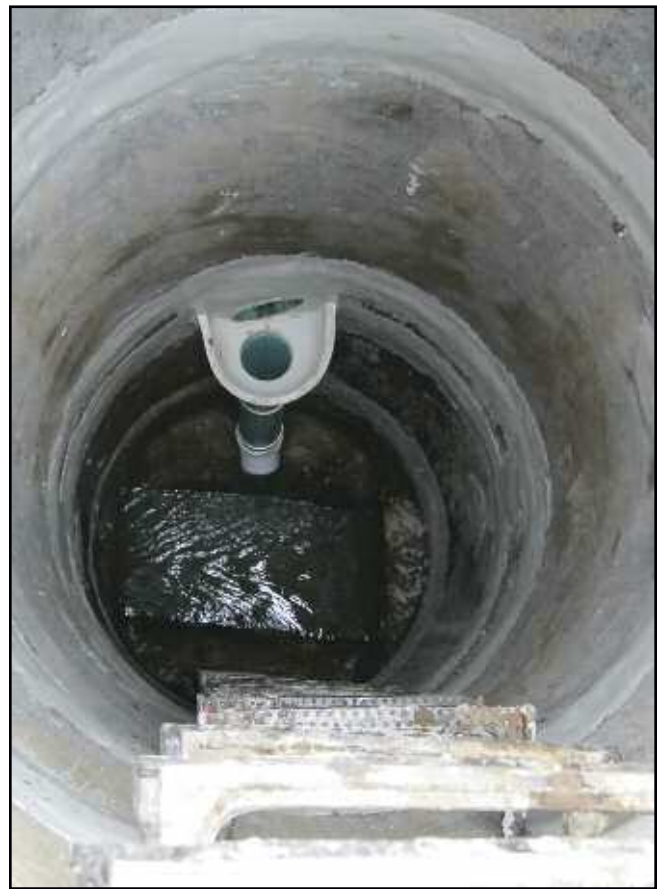
*Figure E: Manhole after rehabilitation*
