Pacific Northwest Trenchless Review

WINTER 2020

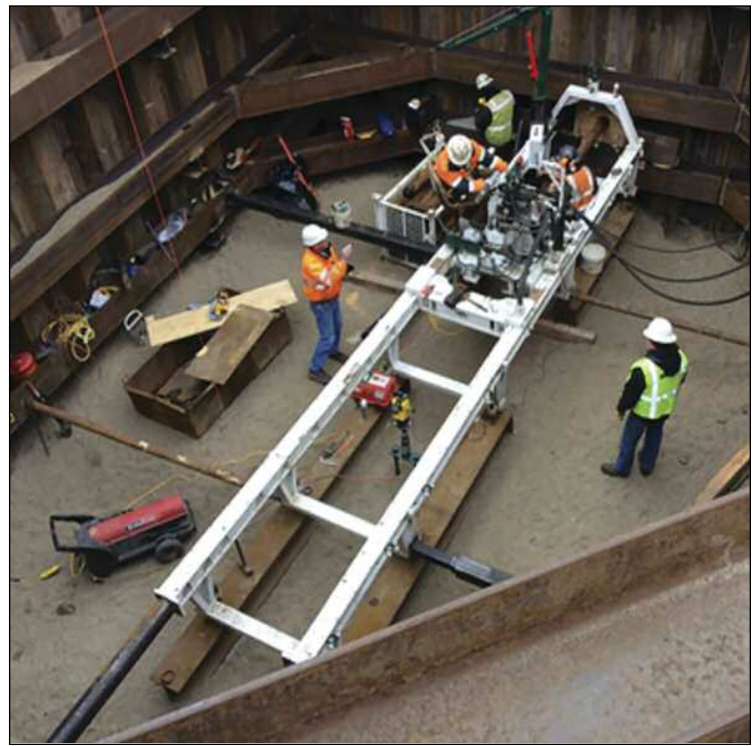
Figure 4. Storm Drain Installation

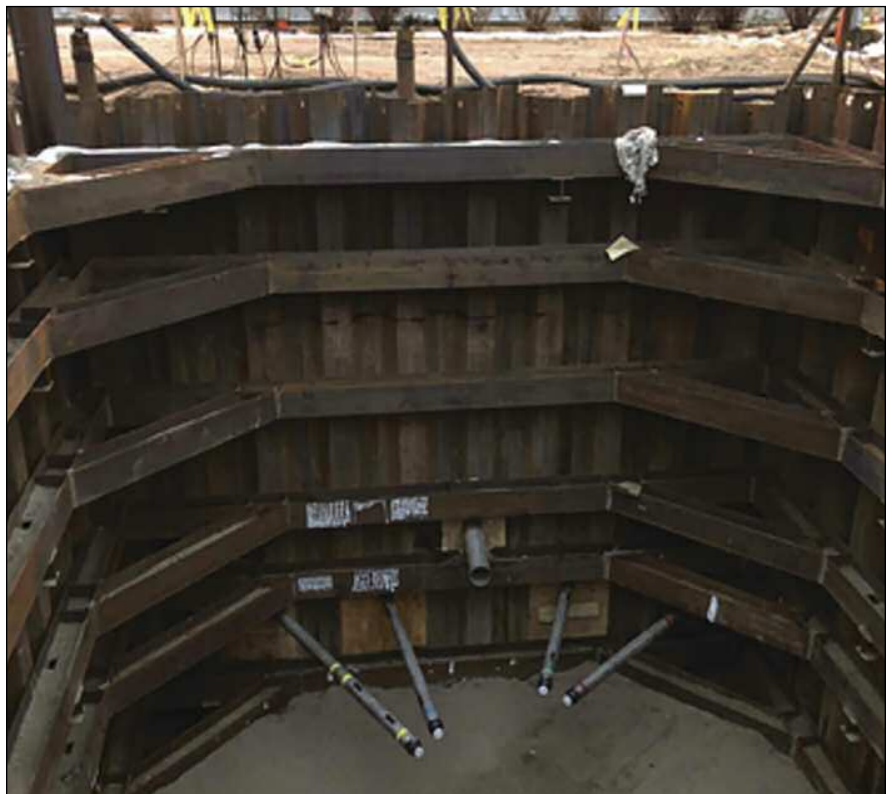
Figure 6. Horizontal Drains Installed

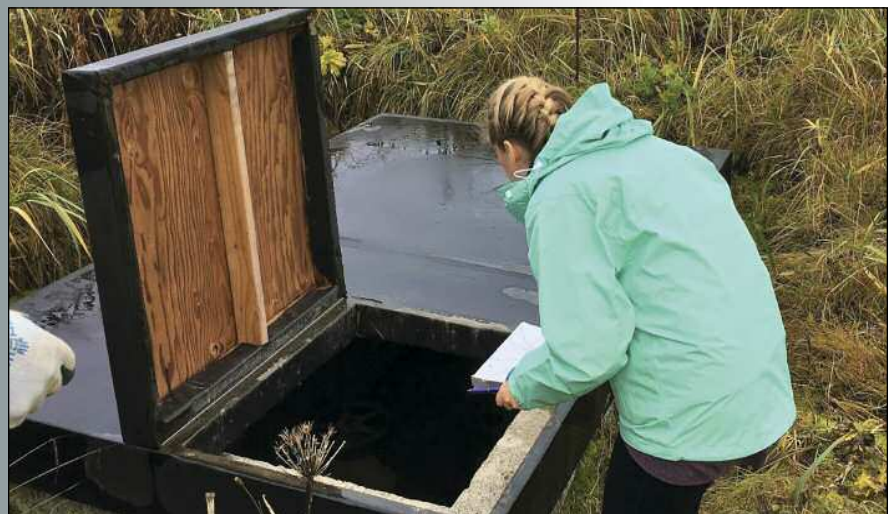
Field inspection of a water vault

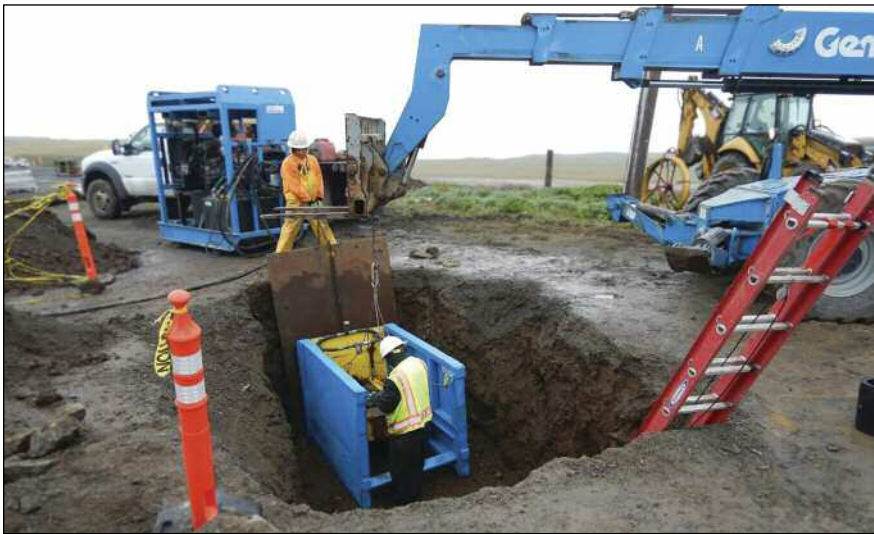
Pipe bursting equipment in an access pit

The design of the D-B project uses pipe bursting; no additional trenchless rehabilitation alternatives were considered due to the tight design schedule. The contractor used a chain-drive static pipe bursting subcontractor to perform the work. The pipe bursting equipment used a 100-ton bursting rig capable of performing in excess of 250-foot pulls.

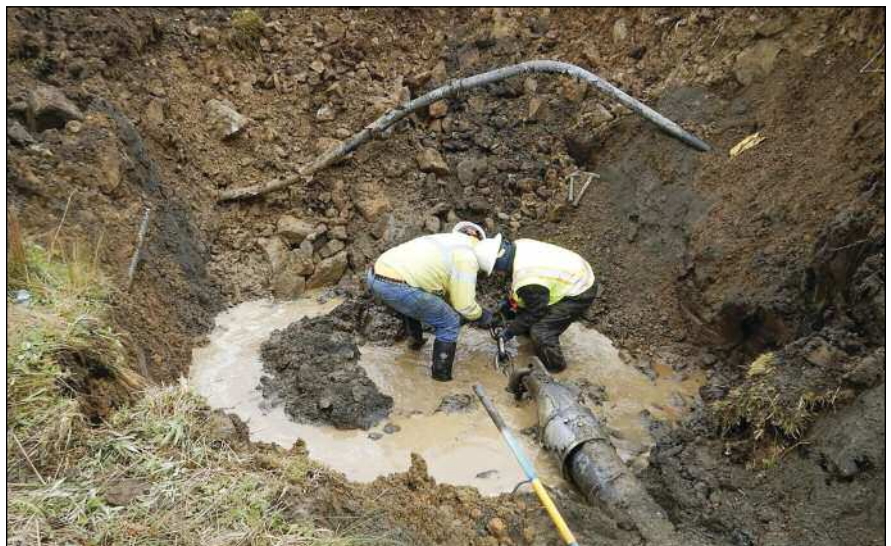
Unknown crossing utility damaged during excavation, not the pipe bursting process

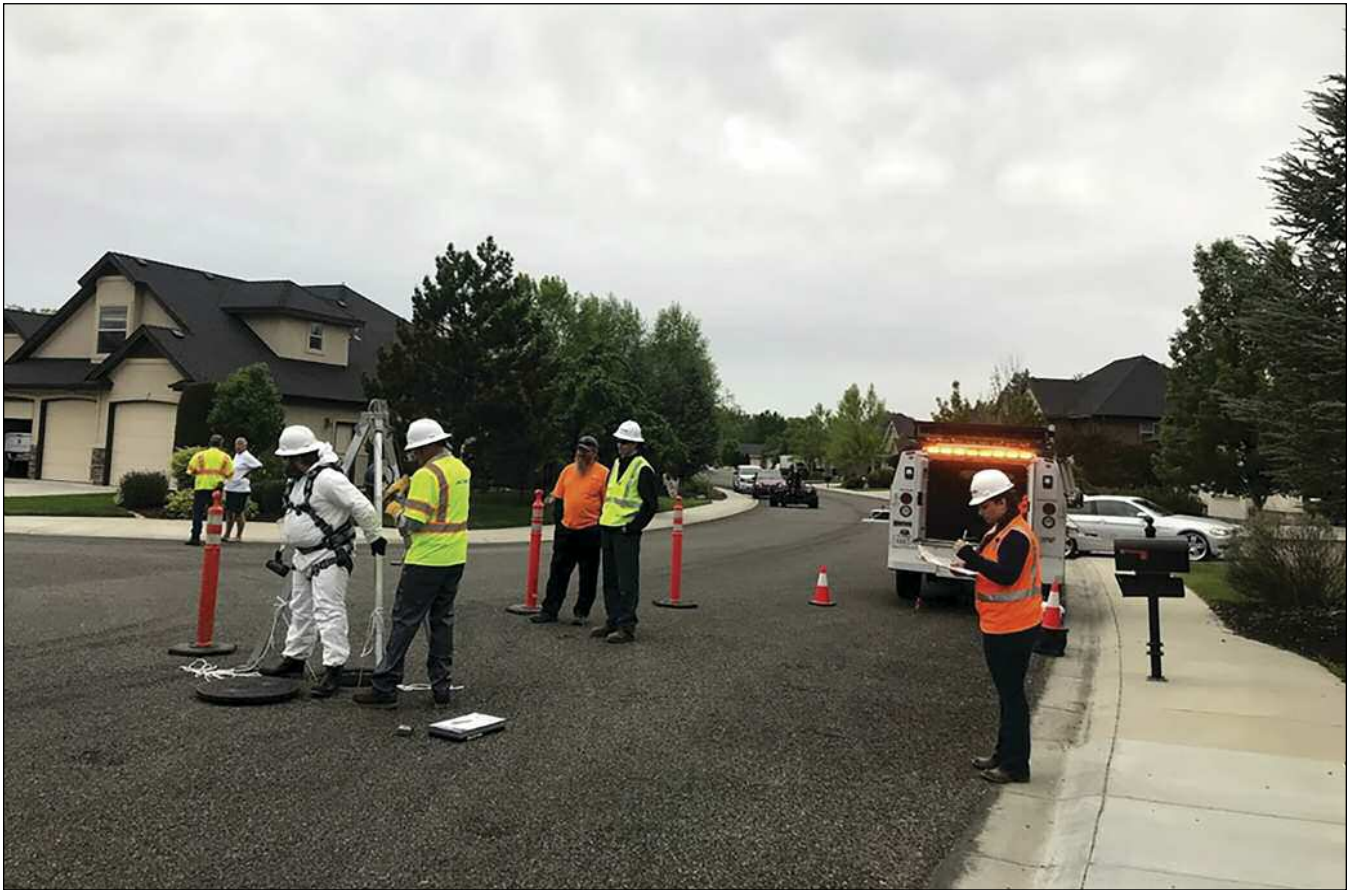
Comprehensive condition assessment requires entering the manhole.

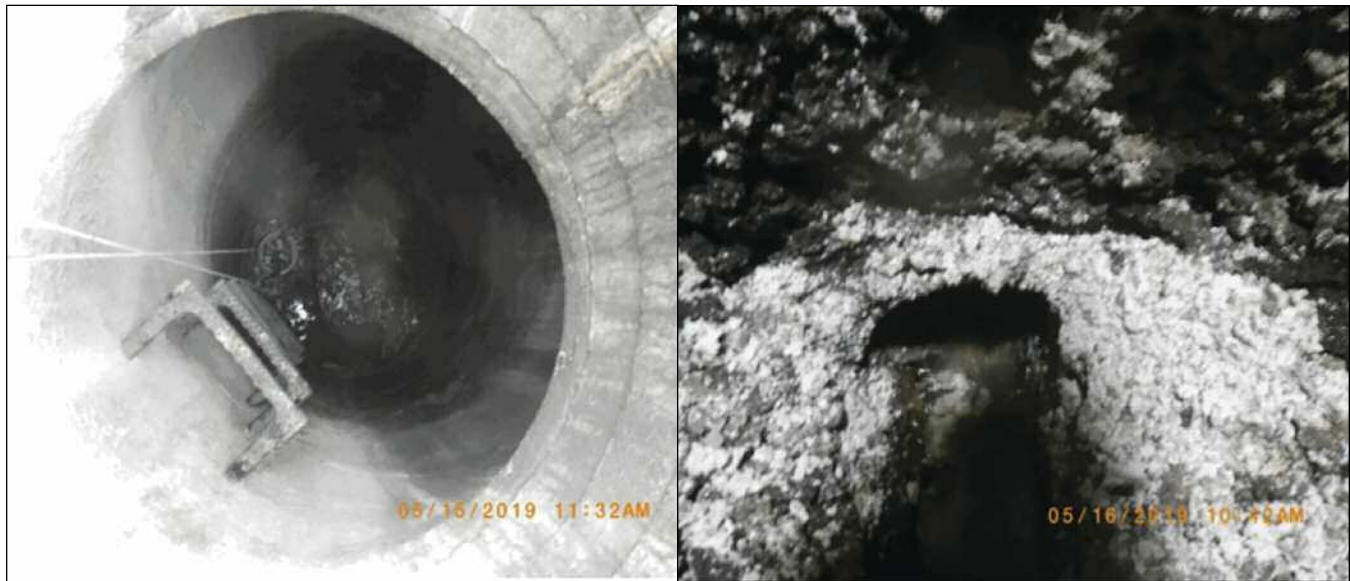
This manhole looks good from above, but closer inspection uncovers problems.

- Cracking
- Depth of corrosion
- Concrete hardness

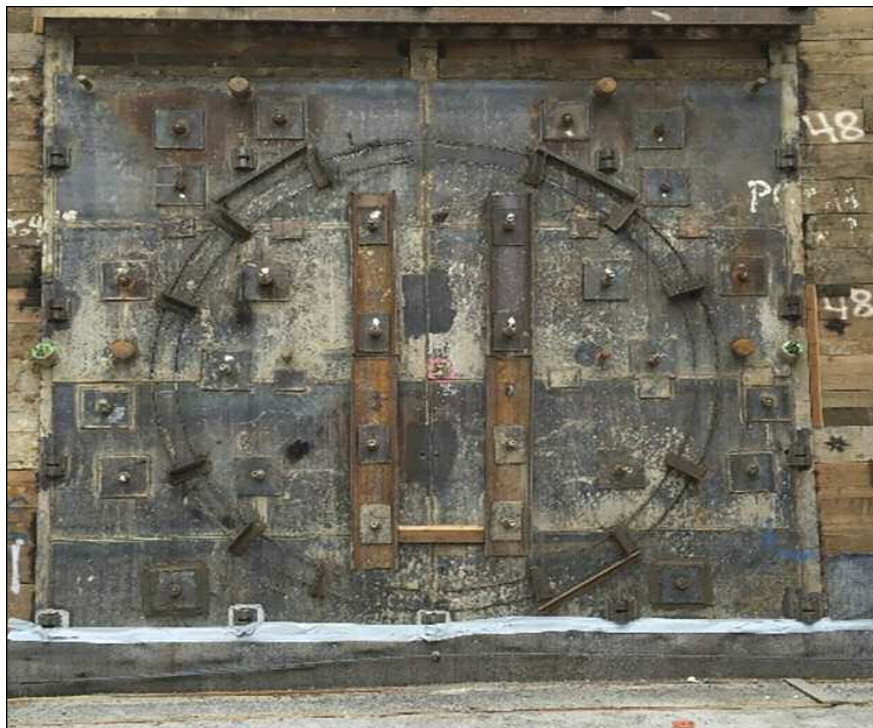
Figure 2. Headwall, OHSU Project

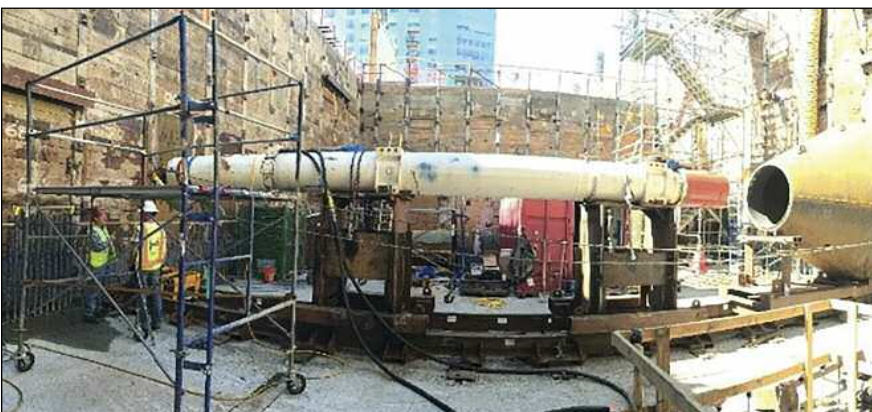
Figure 5. OHSU Tensioning Photo

mers in a horizontal application (e.g. pipe ramming), the same force is necessary to cock the anvil. To achieve this, a tensioning or thrusting mechanism must be created to provide a compression force equal to or greater than the weight of the hammer as the pipe is advanced.

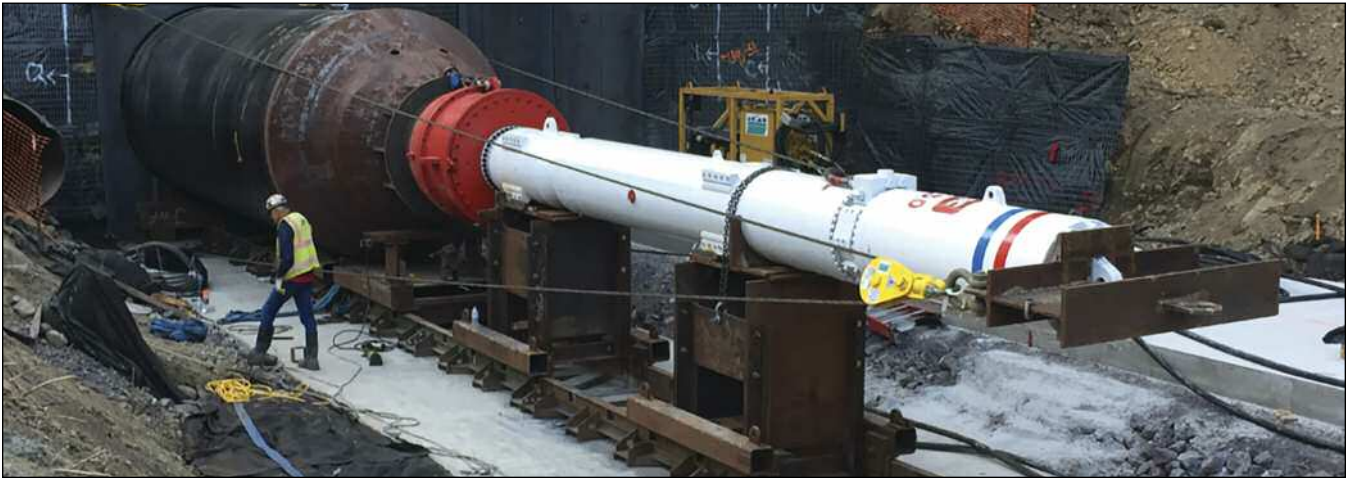
Figure 6. Tensioning System, Ryan Creek Project

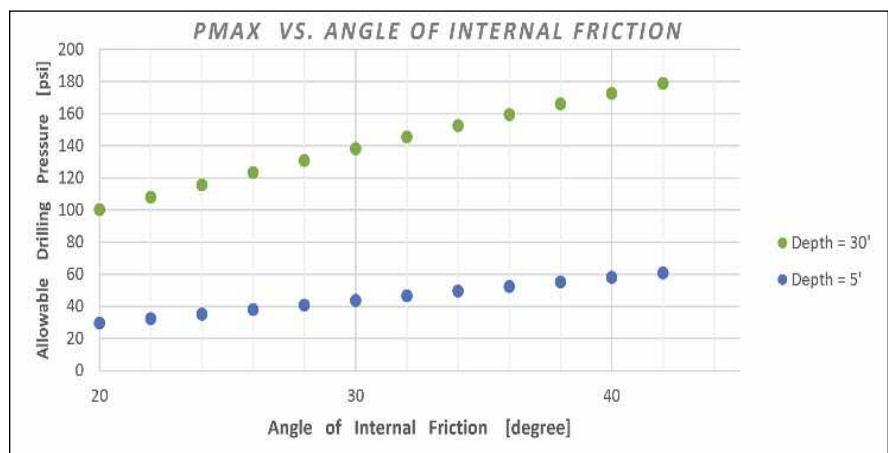
Figure 1. Variation of internal angle of friction against P_{max}

The sensitivity of the internal angle of friction was varied from 20 to 42 degrees. The values of total density and cohesion were held constant at 110pcf and 100psf respectively. The variation of internal friction angle was performed at values of shear modulus ranging from 100ksf to 1500ksf. Figure 1 shows the sensitivity of internal friction angle with shear modulus equal to 100ksf, plotted against the P_{max} . The relationship is captured well by a linear regression, indicating a linear relationship, with an R^2 value of 0.99, which was found to be true for both very soft soils (low shear modulus) and stiff soils (high shear modulus). The parameters were varied in a model simulating both a moderately deep bore (30 feet depth) with diameter 8-inches and a shallow bore (5 feet

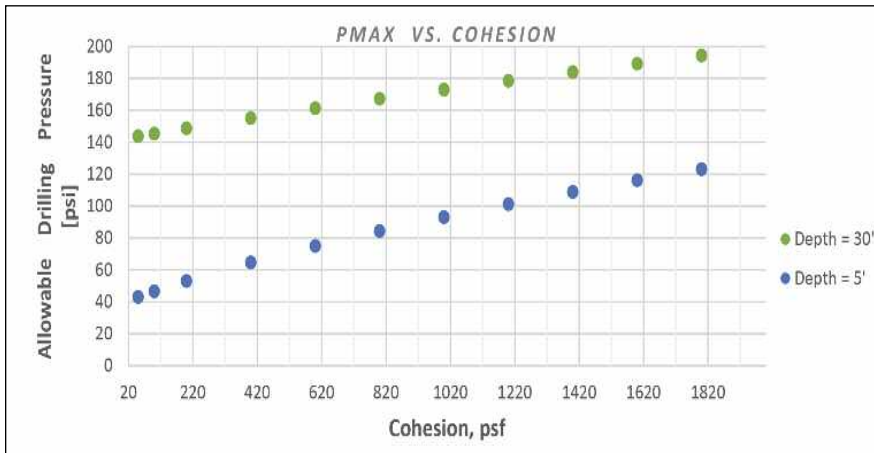
Figure 2. Variation of cohesion against P_{max}

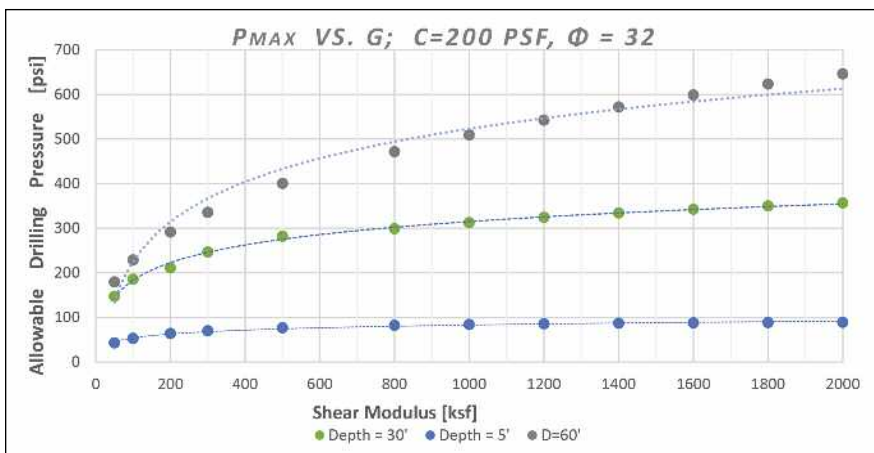
Figure 3. Variation of shear modulus

described by Asperger and Bennett (2011). By varying shear modulus while holding all other values equal, the variation in the calculated P_{max} value has been developed for bore depths of 5, 30, and 60 feet below grade. Figure 3 shows that though each plot has the same general shape, the result is that depth has a large impact the which range of G has the greatest impact to P_{max} . whereas little change is noted in P_{max} when ranging shear modulus from 100 to 200 ksf in a 5-foot deep bore (10% or less), the change in the calculated P_{max} is 35% for the same variation in G in a 60-foot deep bore. Further, the calculated P_{max} reaches a limiting value with respect to G at much lower values at a shallow bore when com-
