Outfall 33 Rehabilitation

Urgent Sewer Repair using Pilot Tube Construction Method

Ruben Gonzalez, M.Sc., P.E.
Bureau of Environmental Services
City of Portland, OR

January 12th, 2017

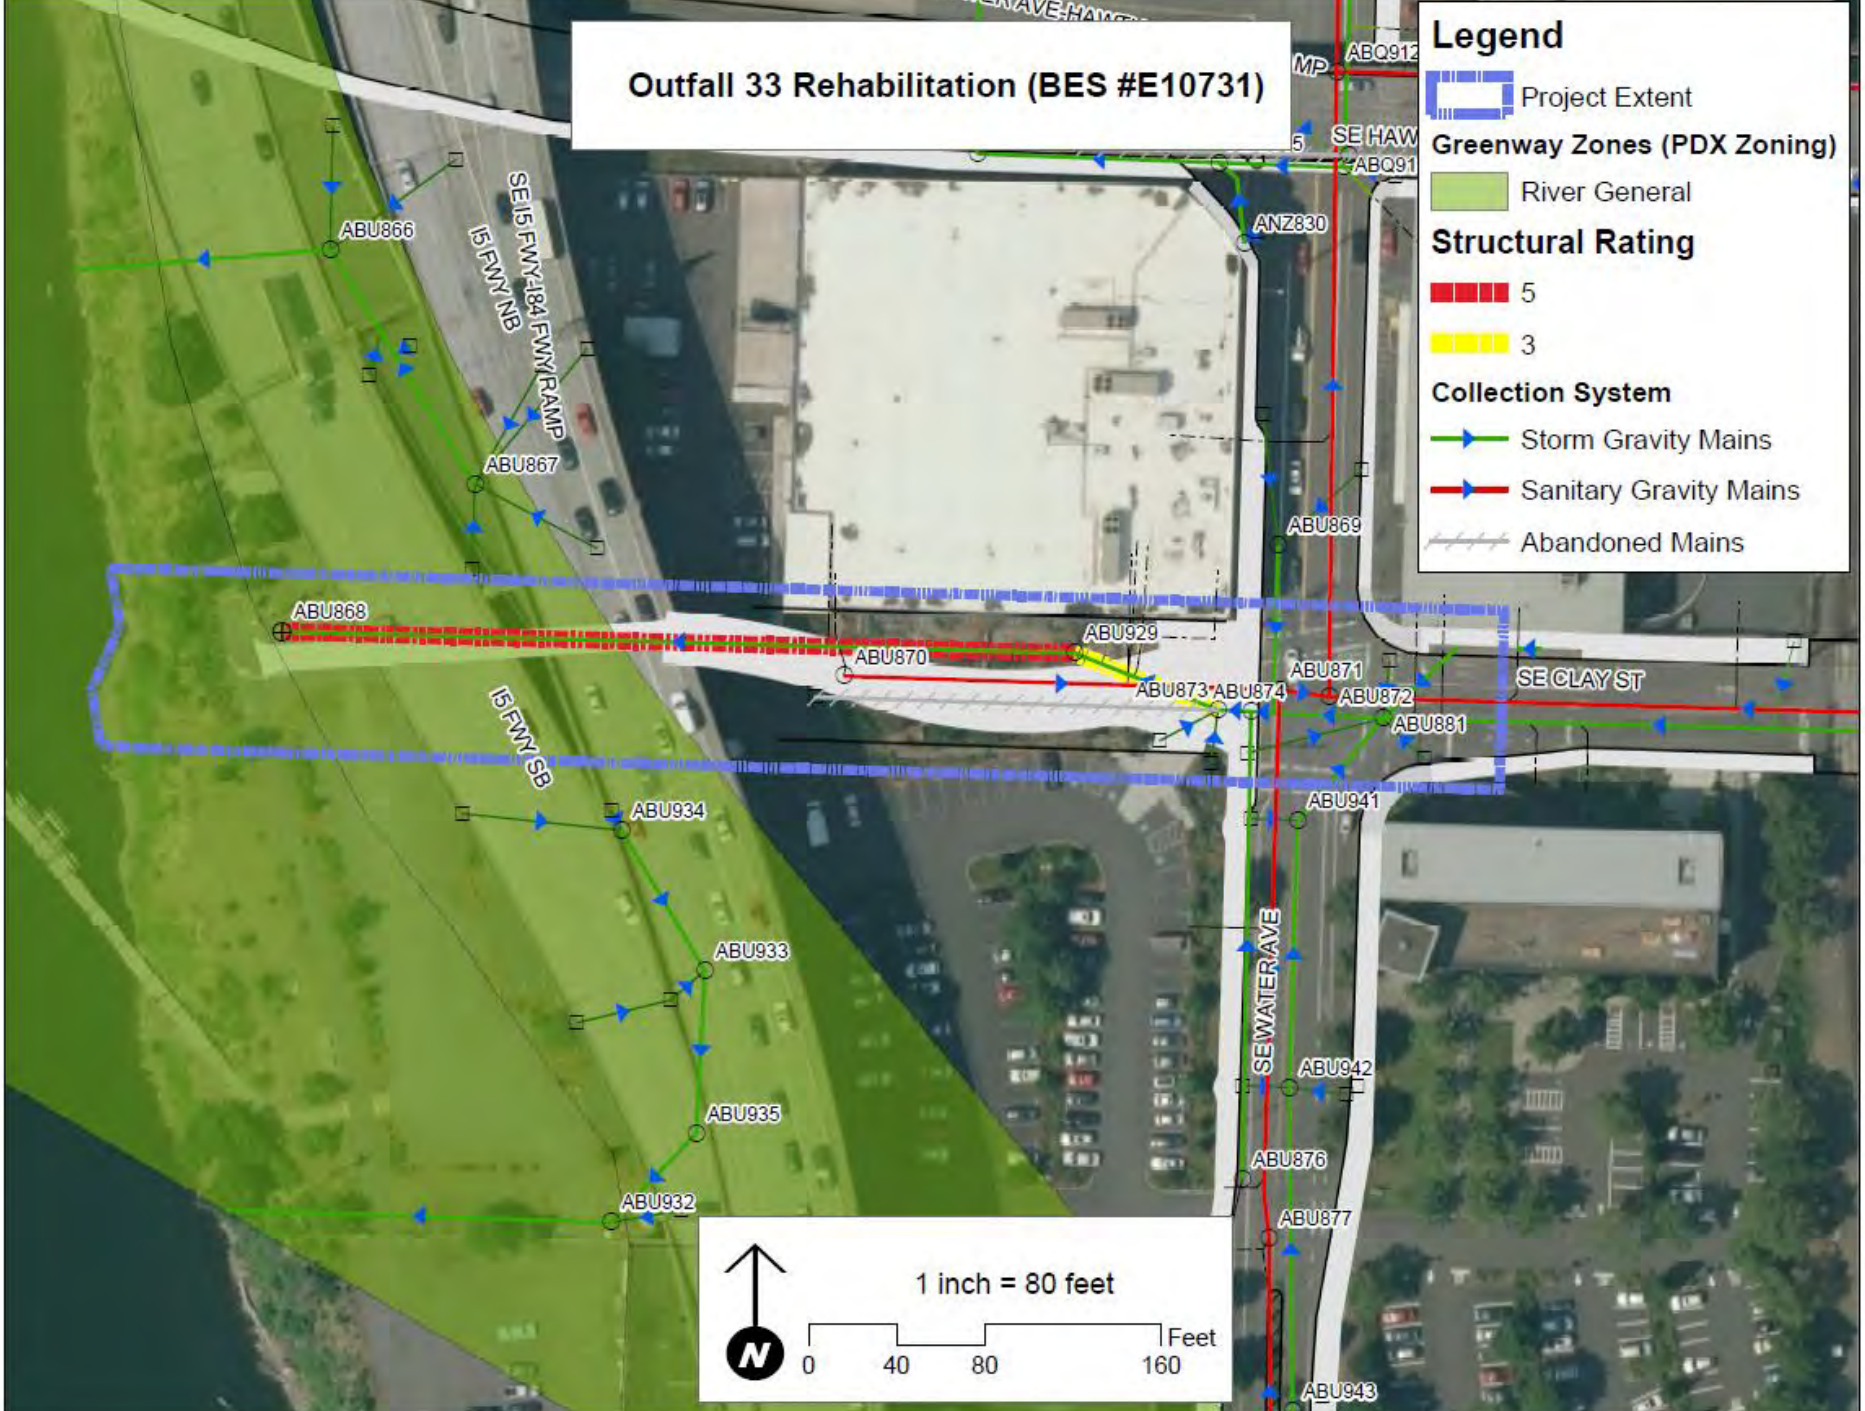
- Recent inspection dates: August, 2015; April, 2014.
 - Pipe segment ABU929-ABU868 has a grade 5 structural score.
 - Pipe segment ABU873-ABU929 has is a grade 3.
- OF33 is buried by undocumented fill.

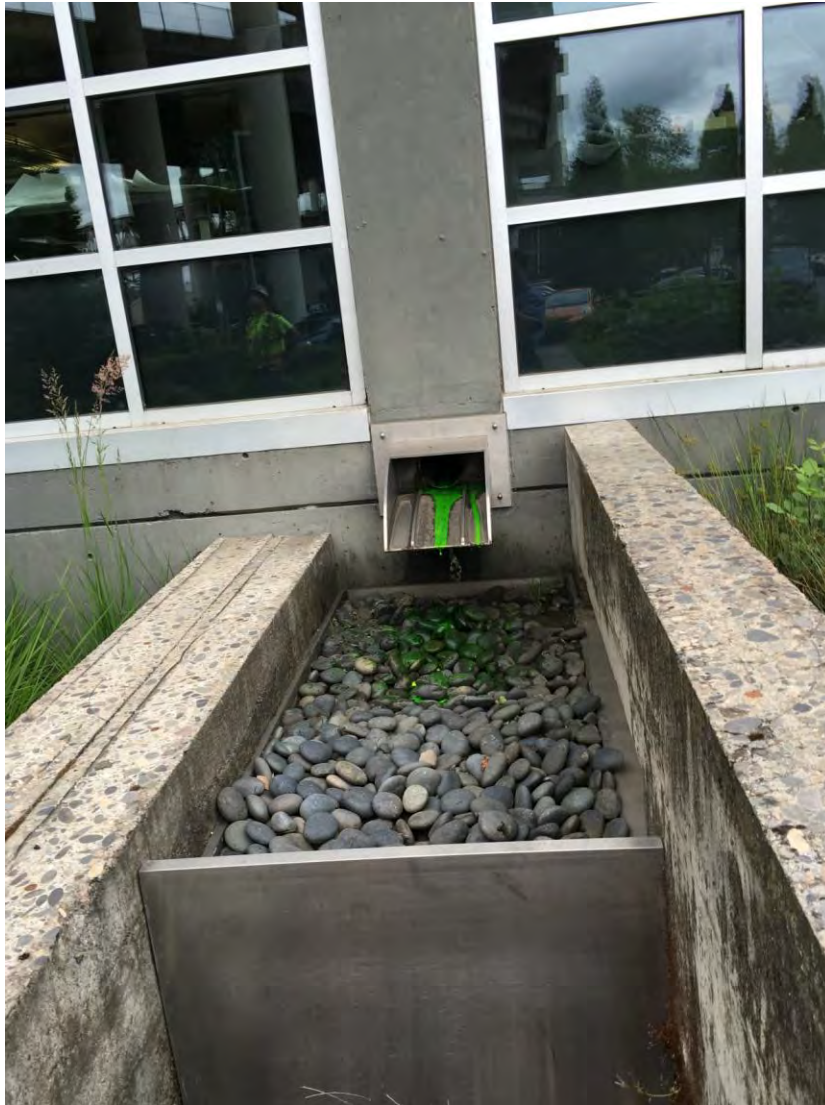
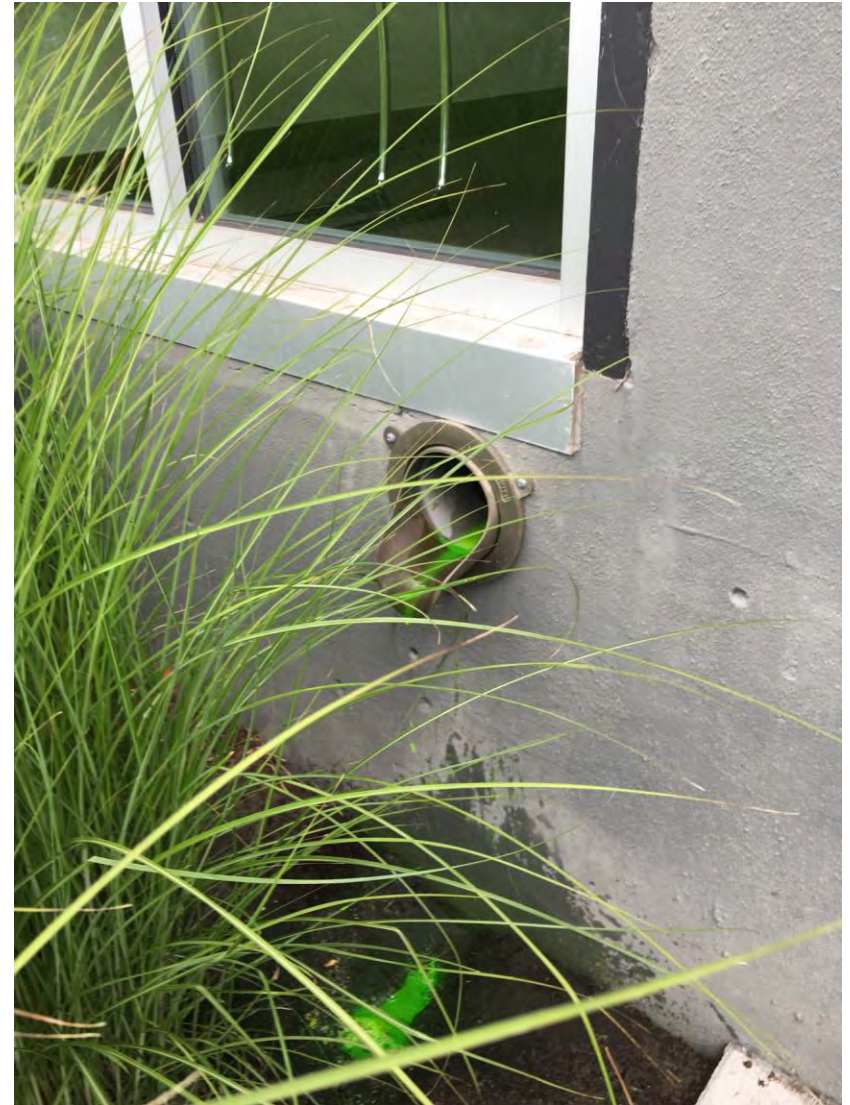
Field Investigations – Inspections

5/26/16:
Connections to storm main, Roof drain confirmed abandoned. Dye testing resulted in drainage from side of building.

5/19/16:
Only incoming flow is from the N and NE inlets.

5/25/16:
Connection to sanitary line. Dye test to confirm if pipe flows into ABU871 (flowing water in pipe; push cam not extended past turn; direction not known; assumed sanitary connection).

5/19/16:
Debris blocking complete CCTV

5/25/16:
CCTV completed for ABU929 to connection with swale at 31.5 ft.
