# Pacific Northwest Trenchless Review

2017

HDD Project A contractor worked through site constraints, environmentally sensitive

A 313-foot-long steel casing was installed under a highway for installation of a water transmission line in Washington

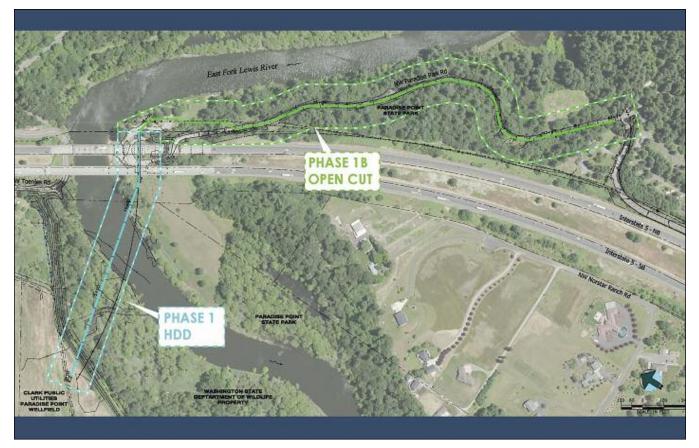
Figure 1. Project Site Location

HDD installation of approximately 1,200 feet of 24-inch-diameter raw water transmission main and a 20-inch-diameter casing pipe for the bundled pullback of an 8-inch-diameter Water Treatment Plant (WTP) backwash pipeline and communication conduits. The design team elected to install a casing pipe rather than perform a bundled pullback of the backwash line and conduits to eliminate the risk of losing one or more of the conduits during pullback. Pipeline installation will continue south from the HDD termination an additional 3,300 feet, utilizing open-cut construction across land owned by the Washington State Department of Transportation and Paradise Point State Park, as shown in Figure 1.

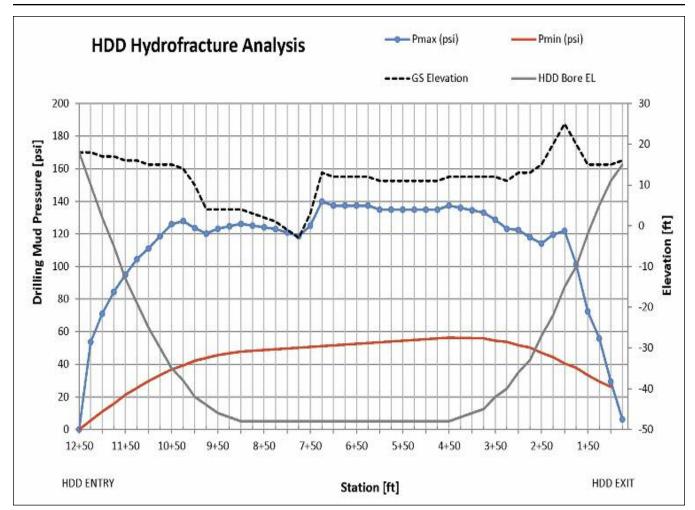
Figure 2. HDD Hydrofracture Analysis

A hydrofracture analysis was performed based on the soil and fluid mechanical properties and the cavity expansion theory (Luger and Hergarden, 1988). The model was developed to establish the maximum allowable pressure that can be applied to a given soil without exceeding the confining stresses in the soil allowing a cavity to expand. At a maximum pressure, a fracture occurs in the soil and the drilling fluid escapes from the expanded cavity.

Figure 2 shows locations along the proposed alignment where hydrofracture has a high likelihood of occurrence due to pressures created during the pilot bore. Where the blue and red lines are in close proximity to each other, the factor of safety (FOS) against hydrofracture is low, and where the red line rises above the blue line, the FOS is less than 1.0, and hydrofracture is expected to occur. hydrofracture

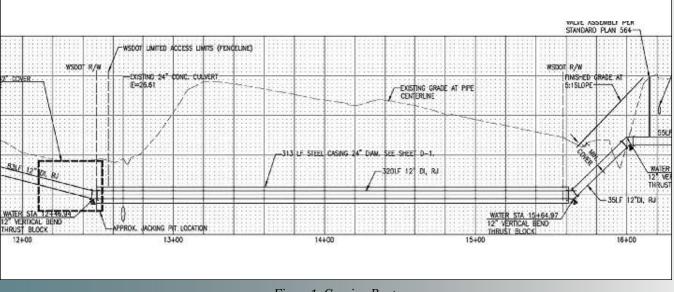
Figure 1. Crossing Route

o facilitate permitting and avoid impacts to SR 522, the locations of the launch and reception shafts (and the length of the crossing) were set outside the Washington State Department of Transportation (WSDOT) right-of-way. An additional constraint on the south side was the Burke Gilman Trail, a heavily used bike and pedestrian trail along the Sammamish Slough. The crossing had to be at least as long as the right-of-way was wide, with the launch pit beyond the toe of the highway embankment. But the launch pit work area could not impact the trail, which needed to remain in use during construction. Additionally, the depth of the steel casing was vertically constrained by trying to maintain as much cover as possible under the highway yet avoid a 24-inch sewer pipe crossing near the launch pit (Figure 1). To have as much cover as possible, the alignment was virtually on the sewer pipe. Near the north end, the depth of cover was about eight feet.

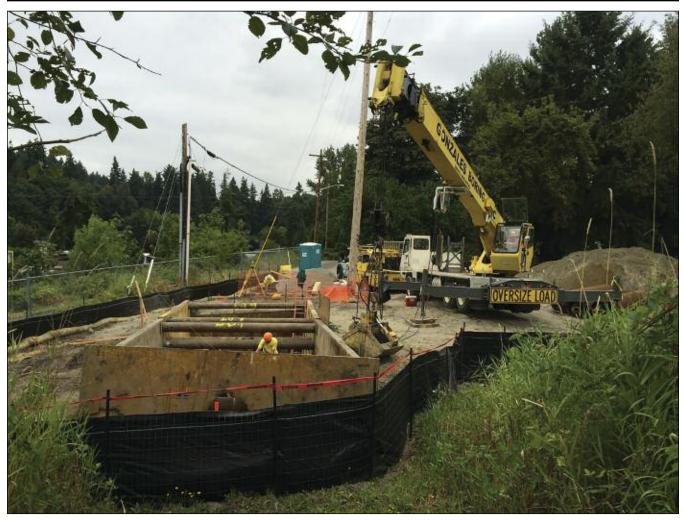
Figure 2. Looking south at the launch pit, trail in background

Construction started in August 2014 with the construction of the launch pit. The launch pit was constructed about 10 feet south of the toe of the embankment. The soils excavated for the launch pit were consistent with what we anticipated. The glacial till was very dense and stood near vertical with minimal support at the face. As shown in Figure 2, the launch site was very constrained, with both the Burke Gilman Trail immediately behind the silt fence (shown in the photo) and an active low-voltage power line about 15 feet from the rear of the launch pit.

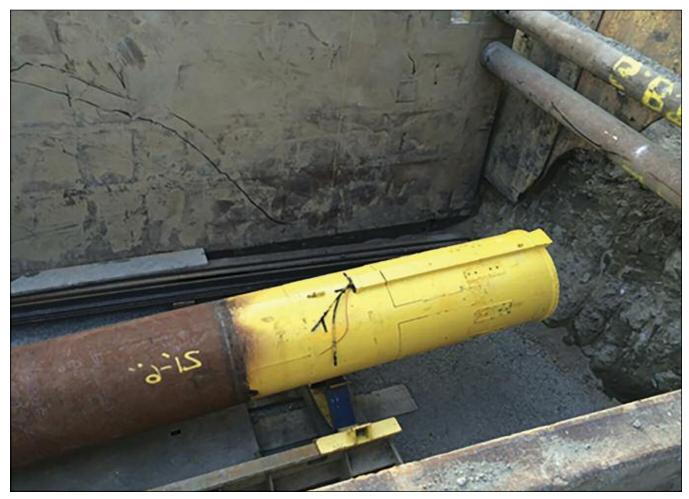
Figure 3. Front steer-guided auger bore (pre-launch)

The contractor set up the auger bore equipment in the launch shaft and elected to use a steerable auger bore. The steerable auger bore with all flaps closed is shown in Figure 3 before it was set online and grade. At the face of the excavation, the glacial till soil is standing vertical.

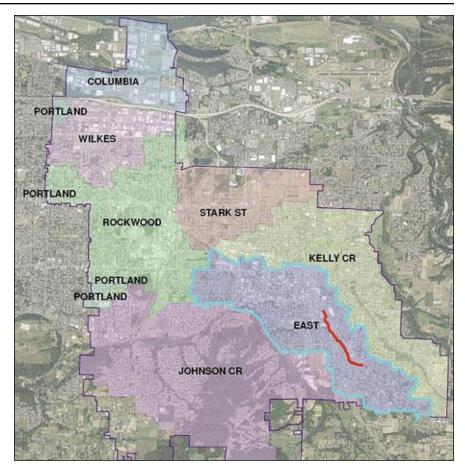
Figure 1 – Gresham's seven drainage basins and two additional plan districts

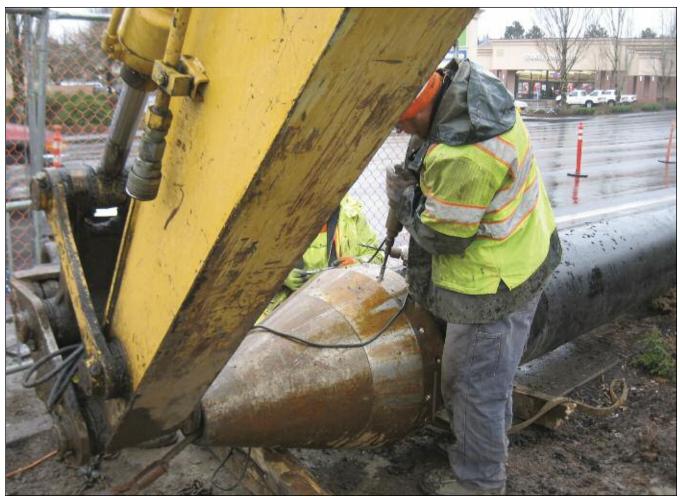
Figure 2 – Example of custom burst head breaking

**INNOVATION:** Recognizing the host of difficulties on the project, City staff made it clear from the beginning that there was a willingness to support innovative solutions. This approach left the door open for different and perhaps more innovative equipment and methodologies. The intent was that this would encourage the contractor to think outside-the-box while troubleshooting, while providing greater flexibility than usual. The advantage to the City would be the potential for breakthroughs as the project progressed to later phases. Among some of the innovations that the contractor incorporated into the project was a custom-fabricated winch for the bursting process. This led to the design of a custom-fabricated bursting head. The concept behind the design was to build a modular head that could be used on multiple pipe sizes. The design included an array of bolts aligned parallel to the alignment. The first instance in which this bursting head failed

was immediately after the head's entry into a receiving pit. While other work was being performed, the contractor and the fabricator revised the head design and incorporated a handful of tweaks. Unfortunately, during the next pull, the head broke before entering the receiving pit. Although the break did not occur in a sensitive area, the depth of the pipe was such that the contractor was still required to use engineered shoring for the retrieval, which added additional time. Not only does such a setback affect the schedule, but it also requires continuous sewage bypass, which exposes both parties to a higher degree of liability. In fact, there was a minor failure of the bypass system during this time which, fortunately, did not spill sewage on the surface as it was confined to the insertion pit. Nevertheless, this spill did require a selfreport to Oregon DEQ. Caught in the City's effort to support an innovative approach, the contractor was informed that they would not be penalized for the schedule delay but they would of course be bearing the costs of retrieval. Despite additional enhancements, the burst head failed a third time during the contractor's next burst. Due to the depth and other complicating fac-

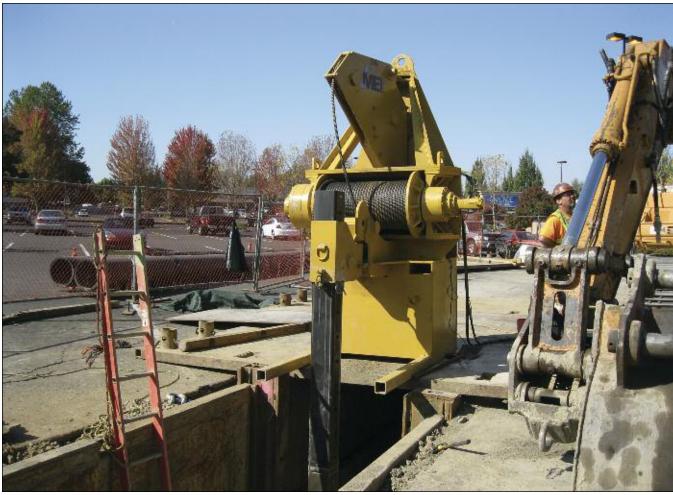
Figure 3 – Custom built winch in operation

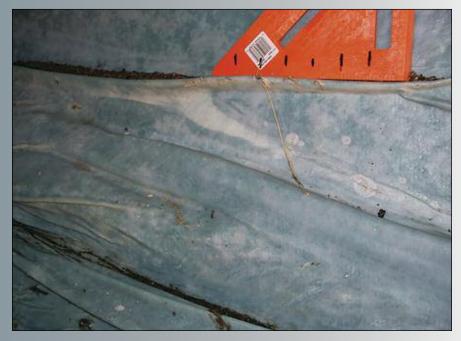
Figure 1. Significant WFF (wrinkles, fins and folds)

contractor as 58 inches, and installed as 60 inches. The results were large wrinkles, fins and folds (WFF) as shown in Figure 1. Investigation found some resin void areas within some of the WFF and other quality issues related to the excessively large liner. The host pipe was later determined to be 55 inches in diameter, not 60. Lesson 1 is not to be "fooled" by map dimensions. An accurate pipe measurement and robust communication process is essential to ordering the right size liner. This process should include procedures by which the pipes are physically measured, forms for recording the measurements, and a chain-of-custody system with checks and double checks. Once the

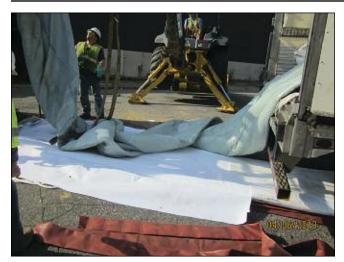
Figure 2. Liner handled with backhoe and sling

The CIPP in Figure 3 (handled and installed in the same way by the same crew as in Figure 2) wound up with severe WFF which were cut out prior to relining the pipe. Using motorized rollers or conveyors and a spreader bar to handle liners reduces and more evenly distributes stress on the liner (and stress on the crew). Cutting or scraping of the liner can result from exposure to rough surfaces or sharp edges as shown in Figure 4. Note that while some of the sharp edges are covered with felt, some sharp edges are exposed to the liner, and the liner is being dragged on the ground.

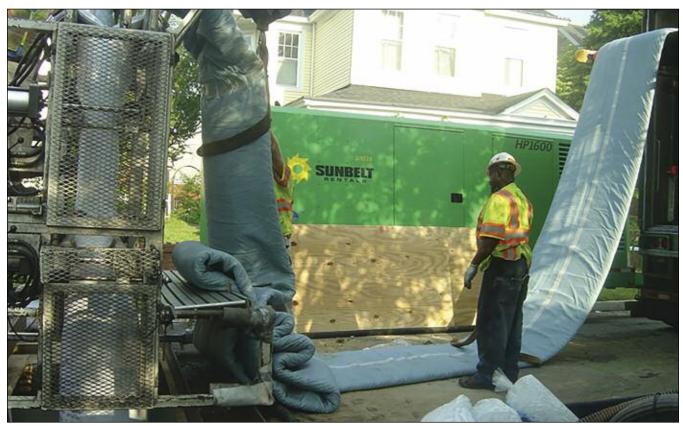
Figure 4. Liner and coating exposed to rough surfaces and sharp edges

Protection of the liner and its coating from damage is critically important. Damage to the coating can result in localized resin washout during installation or leakage through the finished CIPP. Liner handling equipment should be fabricated to eliminate sharp edges. The installation crews should place barriers such as dry felt between rough surfaces and sharp edges to minimize potential for damaging the coating and inner layers. And lastly, the crew should inspect the liner for damage as it approaches the final insertion point and make any field repairs necessary.

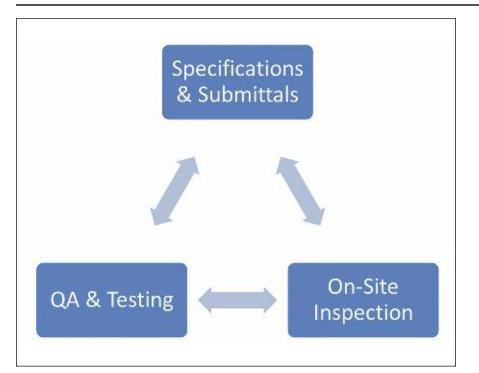
Figure 5. Quality Process Components

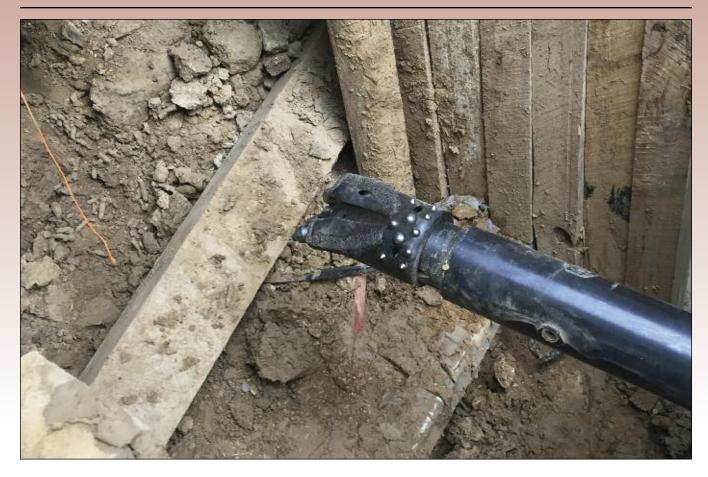
Right out of the gate with the pilot tube installation, initial jacking pressures rose to 70 tons with rotational pressures at 3,500 psi, indicating that the geology was in fact much denser than expected. As a first course of action the contractor pulled back the pilot tubes and replaced the 45degree steering head with the bullet steer-

ing head, designed to aggressively displace high blow count ground conditions. Unfortunately the change provided no relief to jacking and rotational pressures.

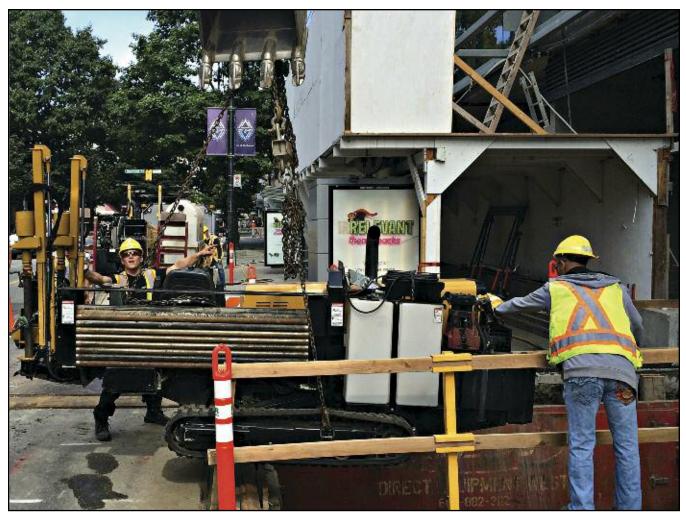
The Canadian City of Vancouver added trenchless technologies to its sewer operations construction toolbox in 2015.

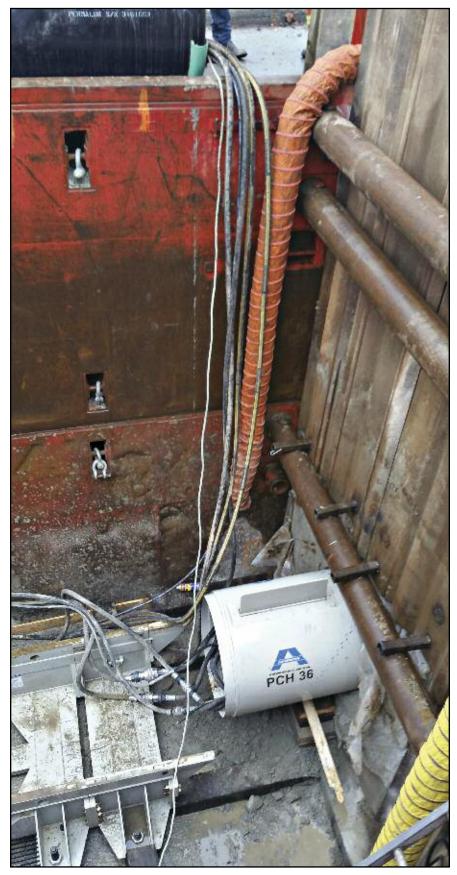
Trenchless technology was used for the major sewer line crossing located on Granville Street at 33rd Avenue and 29th Avenue.

Once casing pipes were pushed through, the fiberglass pipe was slipped in as the carrier pipe on skids and grouting of the annular space was done. Despite minor setbacks due to unforeseen ground conditions. Even though bore logs and the geotechnical report showed ideal ground conditions for the pilot tube method, large isolated pockets of cobbles and loose sand were encountered along with large rocks. However, the crew persevered and successfully completed both crossings.
